CLINICAL CASE

Re-treatment of Thermafil carriers on #14 and #15

Serena Lee

Endodontic resident, PGY-2

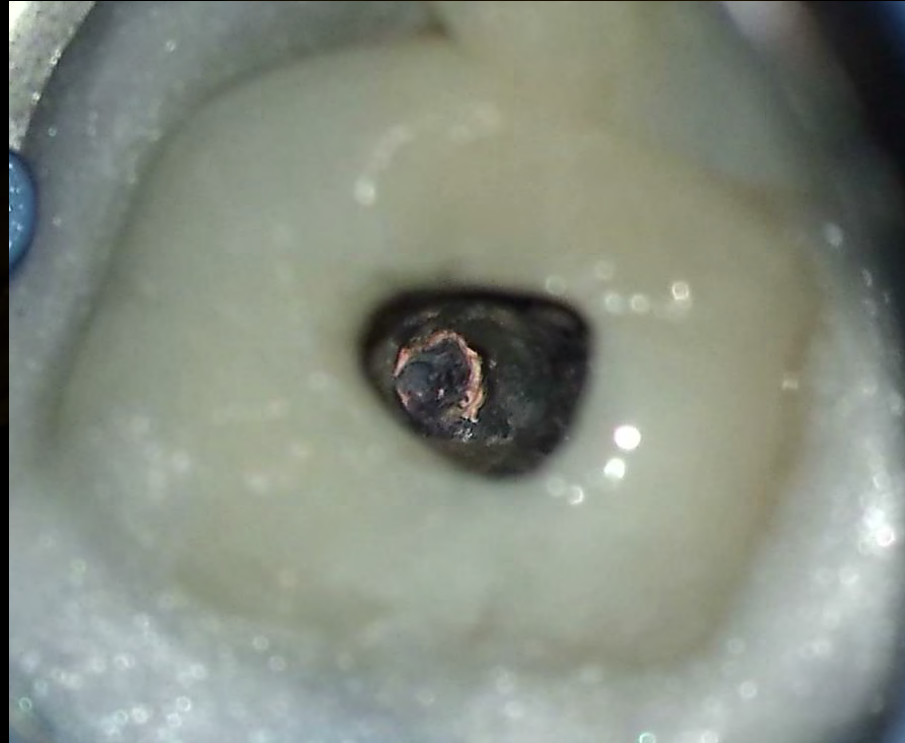
Clinical presentation of a Thermafil carrier

This is an example of what a Thermafil carrier looks like inside an access cavity. Inside the canal, a dark-gray plastic carrier is surrounded by gutta percha.

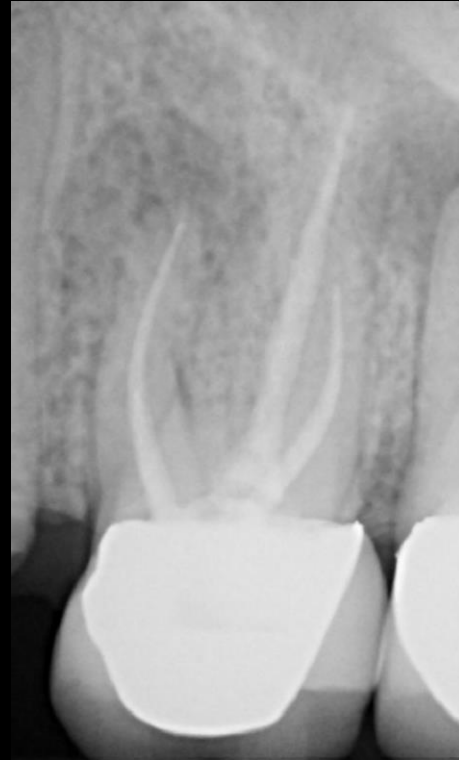
- #14 and #15 have coronal radiopacities that are consistent with resin core build-ups and PFM crowns
- #14 and #15 have radicular radiopacities that are consistent with root canal fillings
- A PARL is associated with the MB roots of #14 and #15

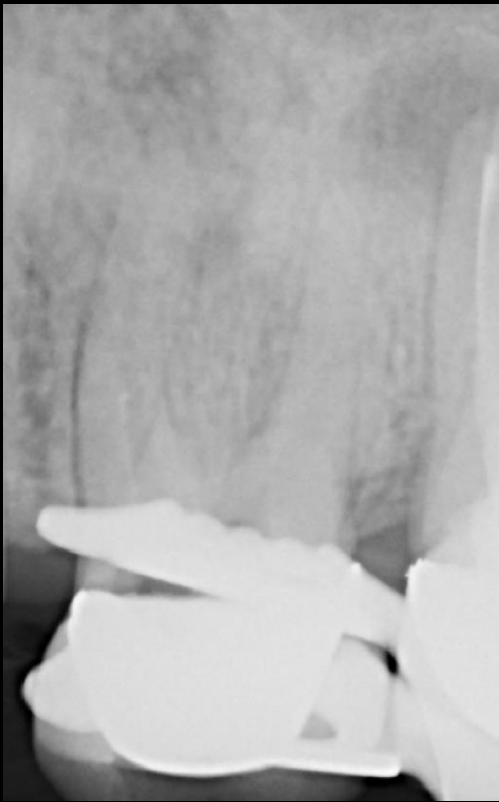
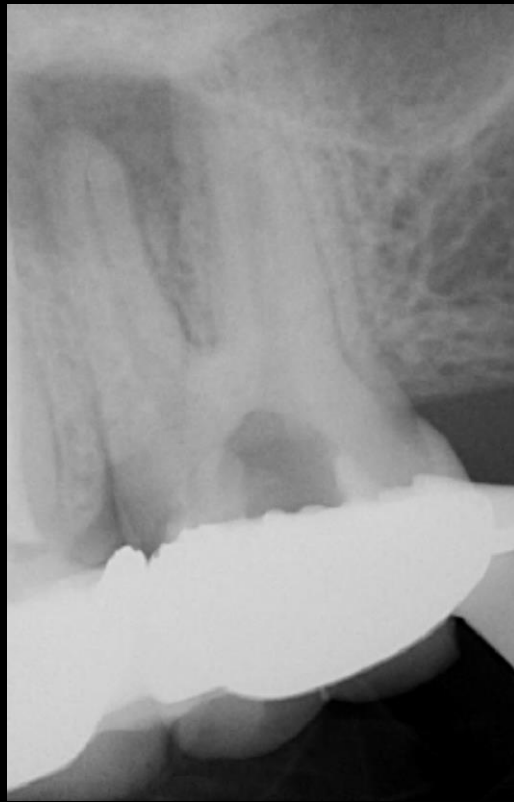
Removal of Thermafil carriers in #14 and #15

PA radiographs of #14 and #15 were obtained to confirm the removal of Thermafil carriers.

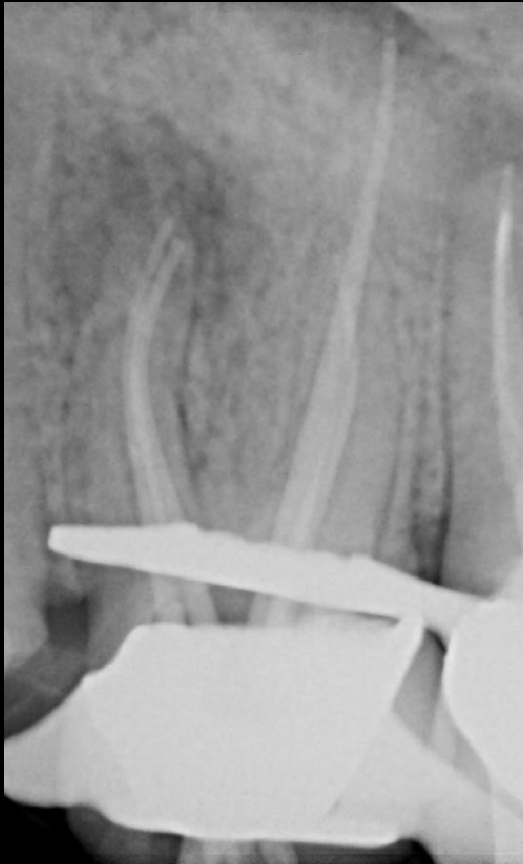
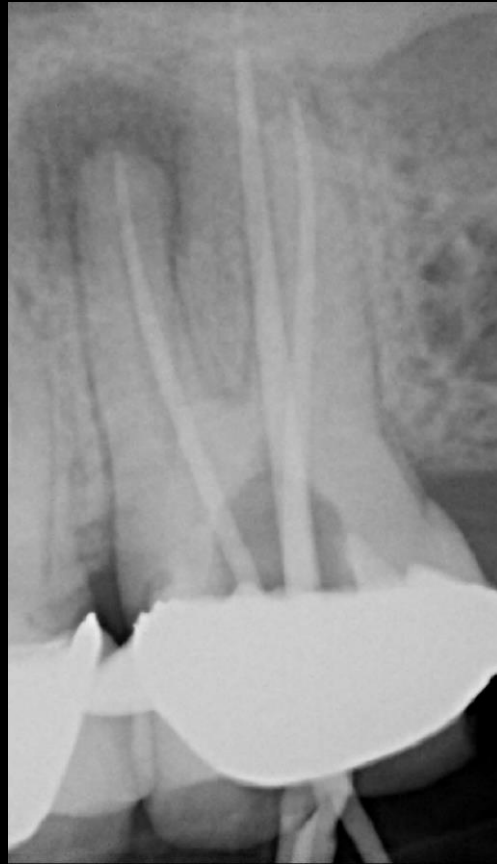
Master cone fit in #14 and #15

PA radiographs of #14 and #15 were taken to confirm the fit of gutta percha master cones.

- EDTA and troughing with an ultrasonic tip was used to identify mineralized MB2 canal orifices
 - An MB2 canal was identified in #14, but not in #15
- Once the MB2 orifice was located, RC prep and a series of #6, 8, and 10 k-files were used to achieve patency
- Working lengths for all canals were determined using an EAL
- Cleaning and shaping was performed in all canals using rotary instrumentation
 - TruShape was used in previously treated canals
 - Vortex Blue was used in the MB2 canal
- Apical patency was confirmed with EAL
- Final irrigation was performed with 17% EDTA followed by 8% NaOCl + PUI
