Restoring Dentition with Indirect Restorations using Trios and CEREC

Digital Dentistry

Marwa Elkharsity, DDS 2020

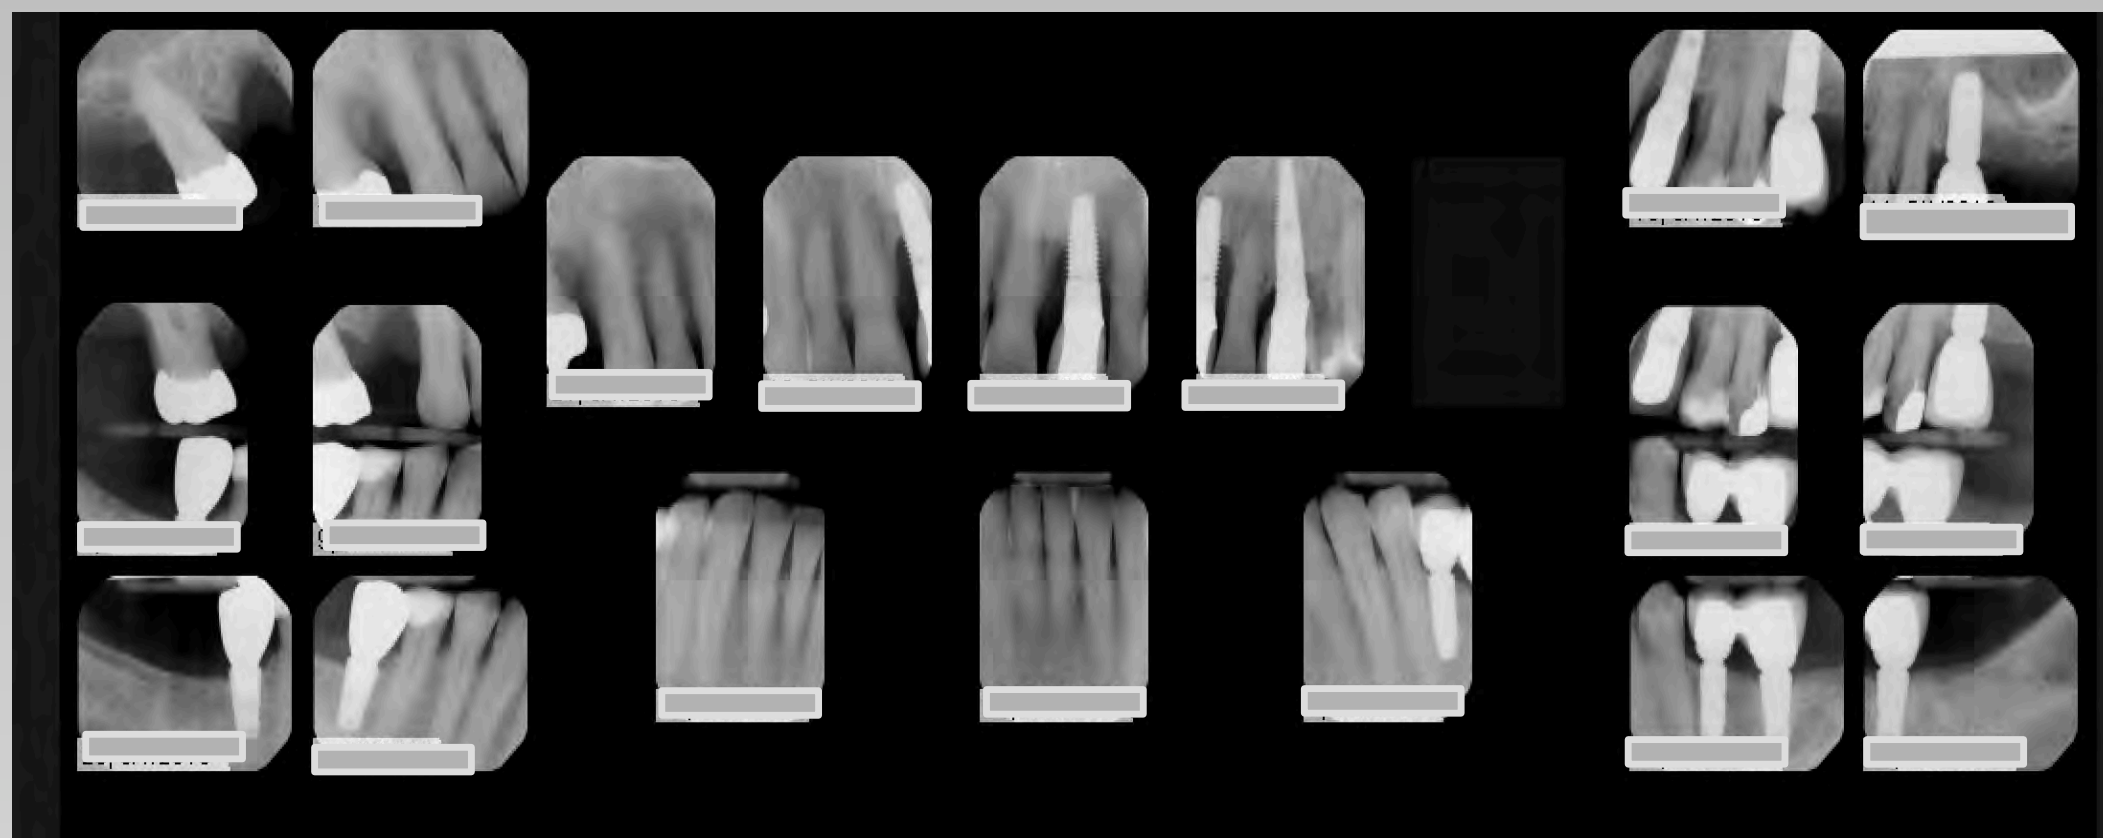
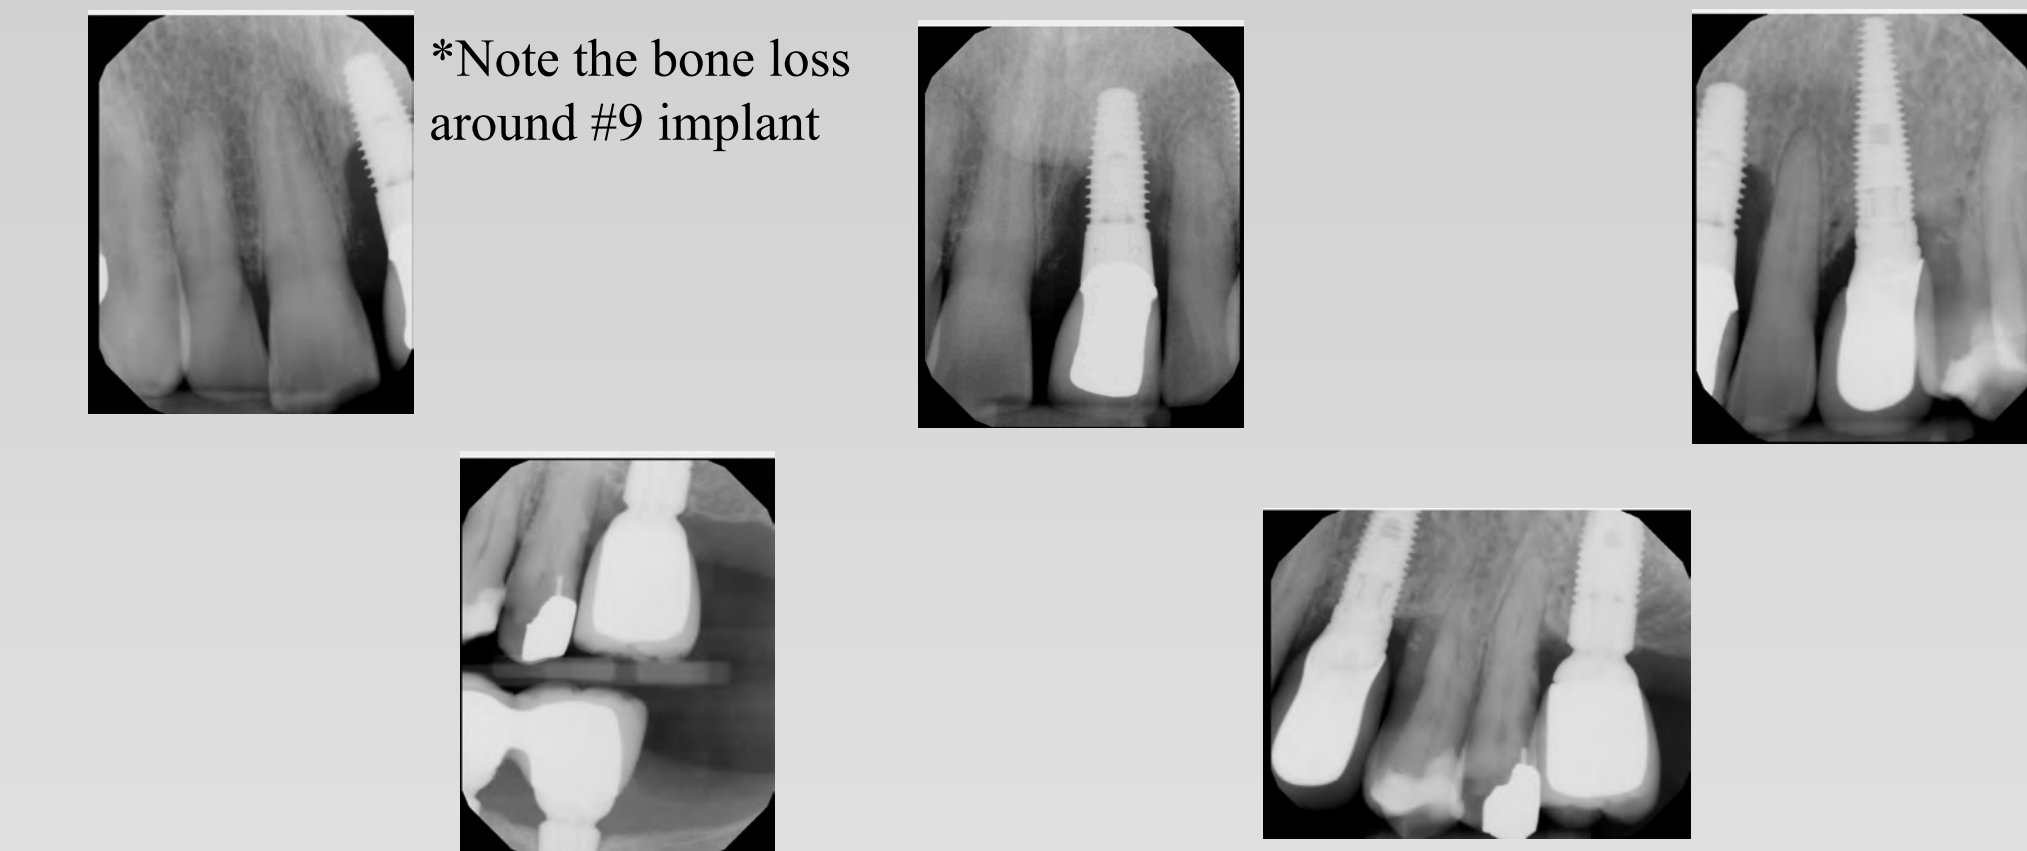
Radiographs

*Note the bone loss around #9 implant

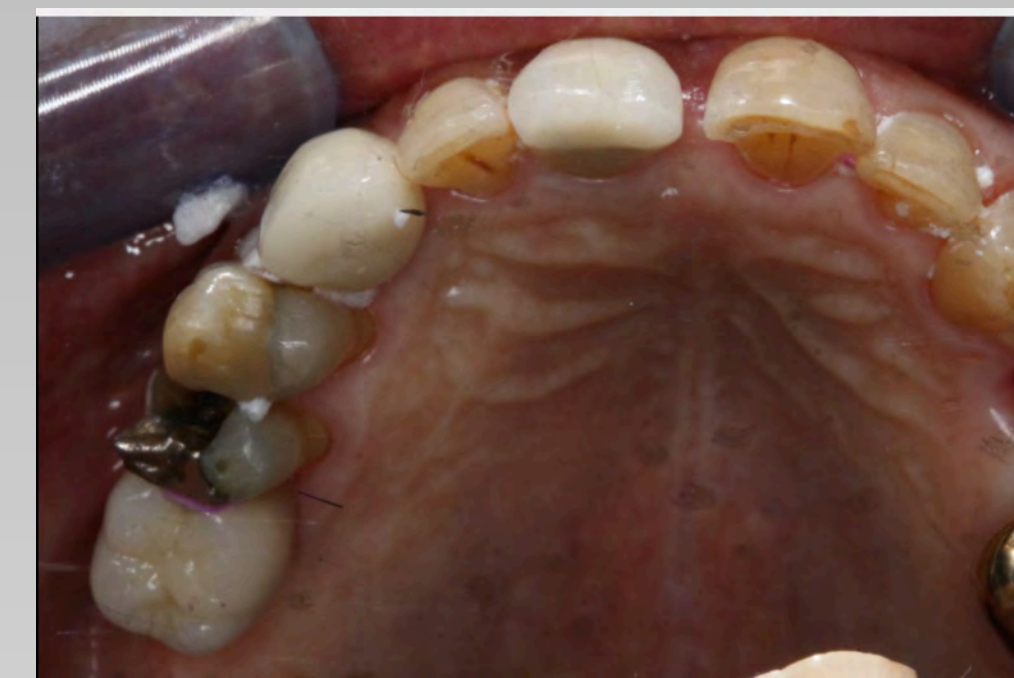
Image 1: Initial Exam Maxillary

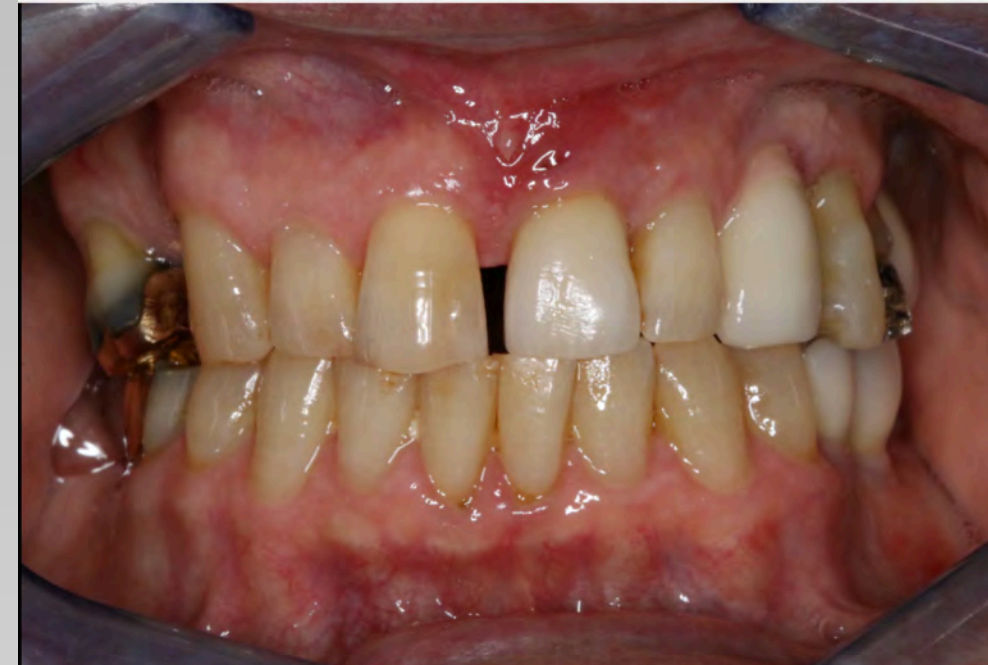
Image 2: Anterior view showing edge-to-edge occlusion

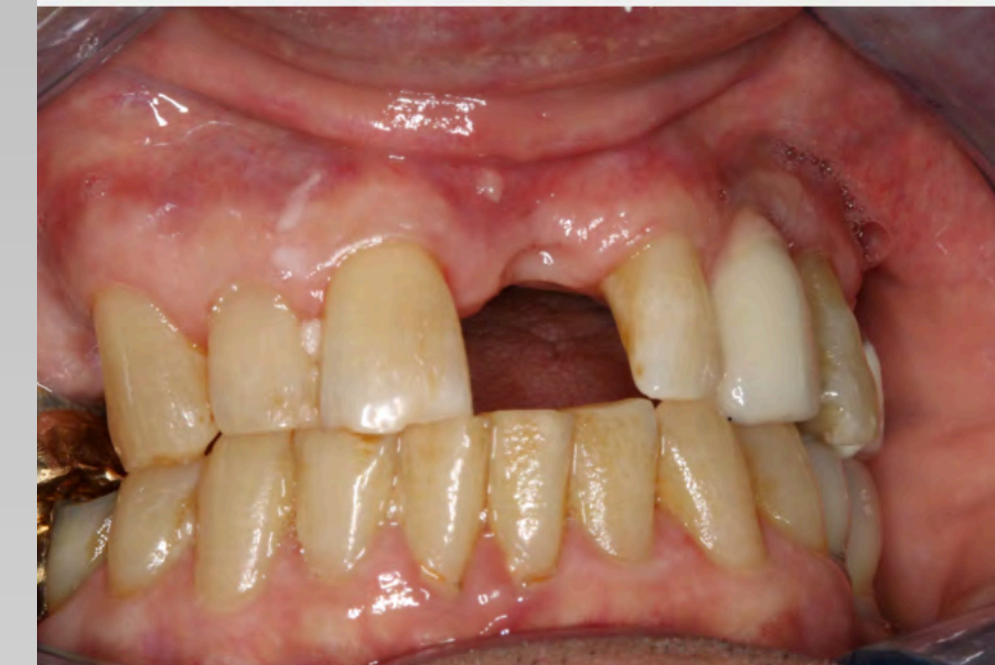
Image 3: #9 implant presented with a sinus tract and bone loss

With the failing implant in site #9, the patient was initially interested in implant placement but due to limited buccal plate the patient opted for bridge placement.¹ The patient was only interested in fixed options; this eliminated the partial as a treatment option.² Studies have shown that patient compliance plays a larger factor than meeting Ante's Law in the prosthesis longevity. Due to the patient's history of compliance, the bridge was determined to be the most suitable for this patient. Monolithic Zirconia was determined over Layered Zirconia due to edge-to-edge bite causing increased chance of layered zirconia fracture.

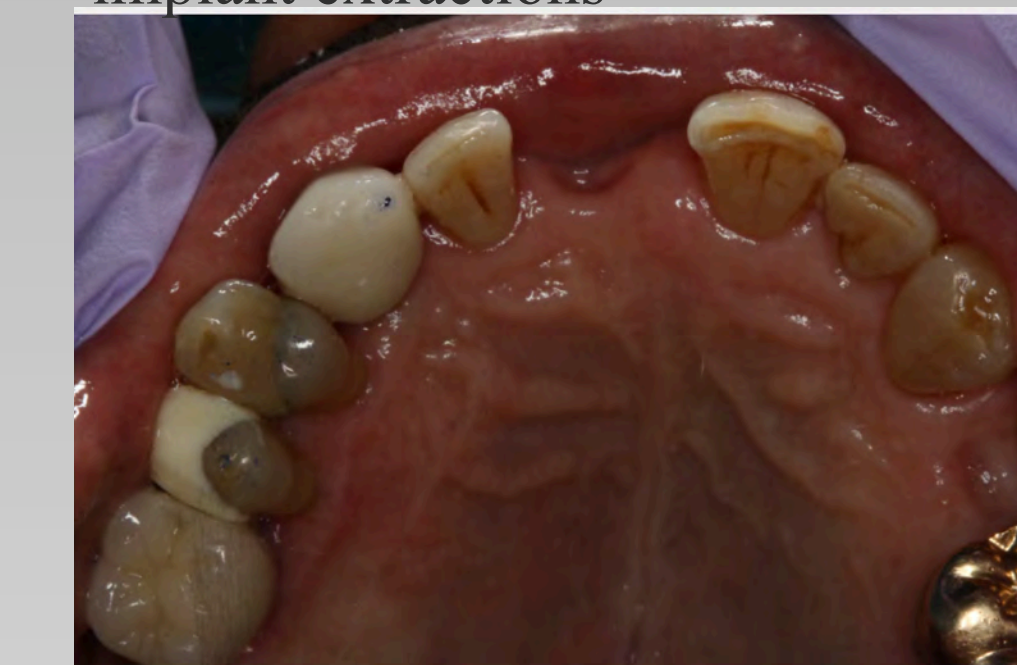
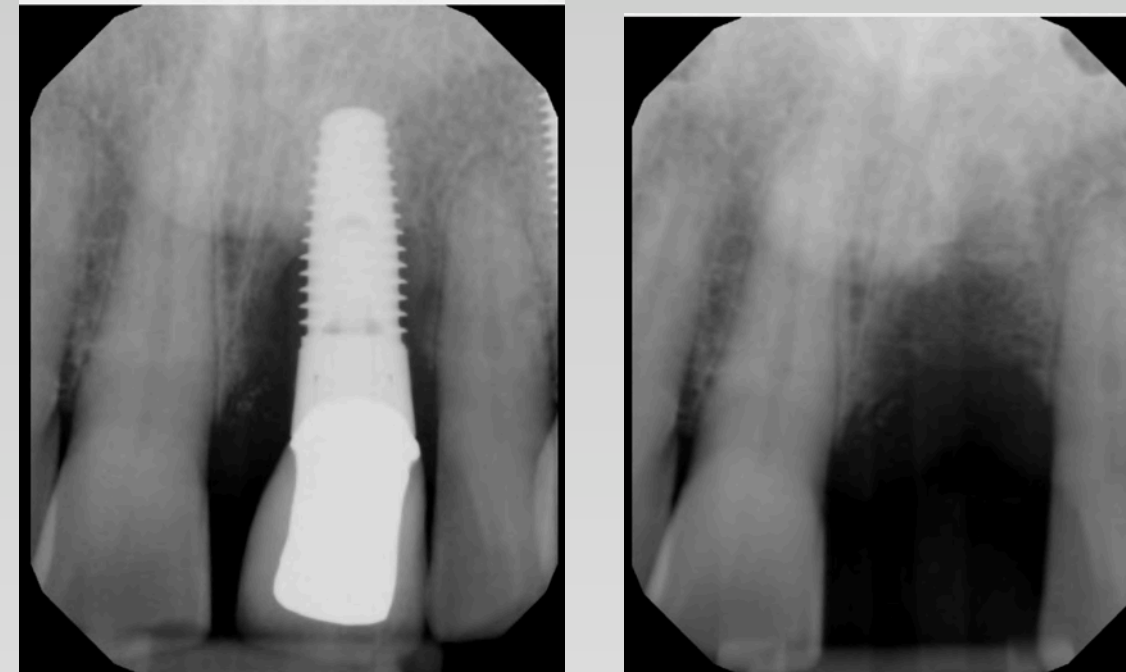
Image 4: Occlusal view after #9 implant extractions

Image 5: #9 implant with significant bone loss, the image on the right shows 3 months post-implant removal. This X-ray was also used to determine bridge restorability

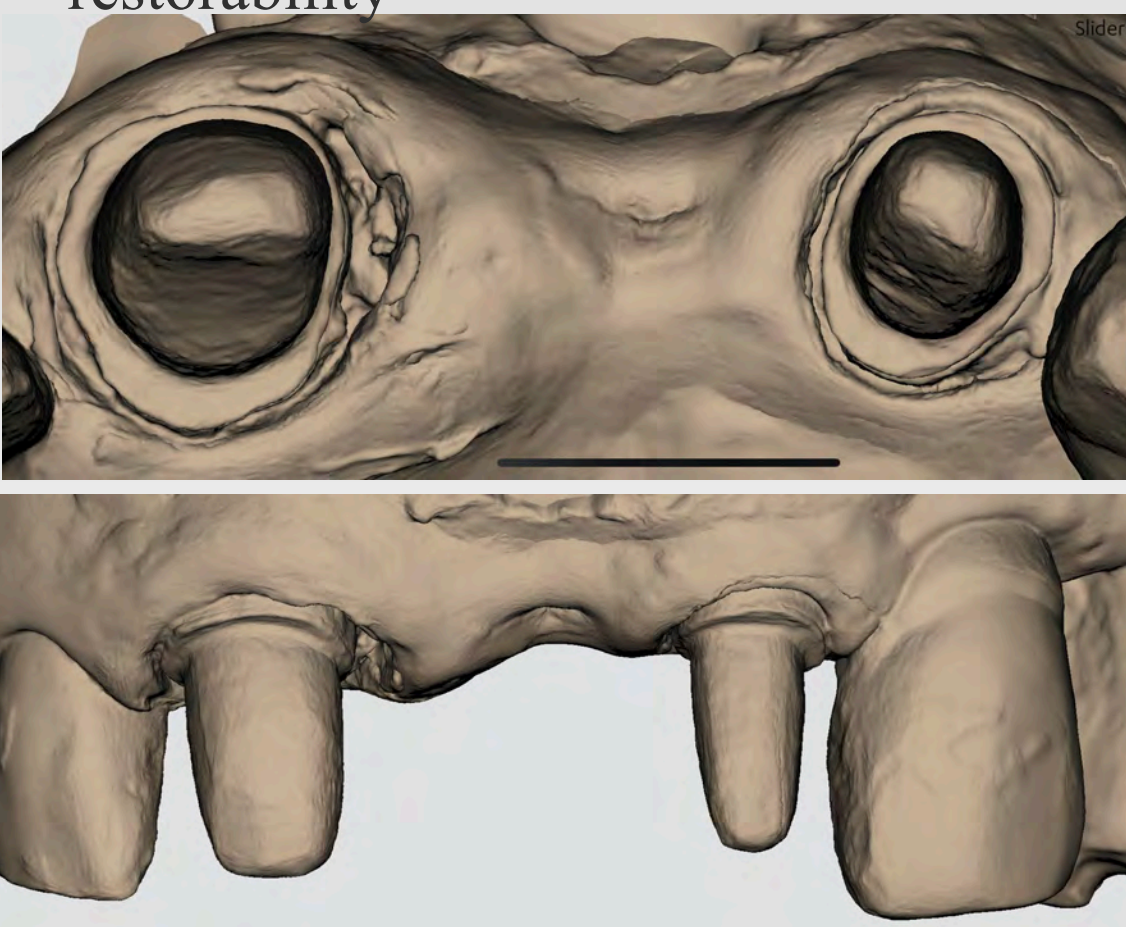
Image 8: view of #9-#10 bridge preparation, showing draw

Image 9: Trios Scan of Prepared #9-#10. Difficulties arose due to limited free gingiva the patient had on the mesial-palatal side of #9 and distal-palatal side of #10.

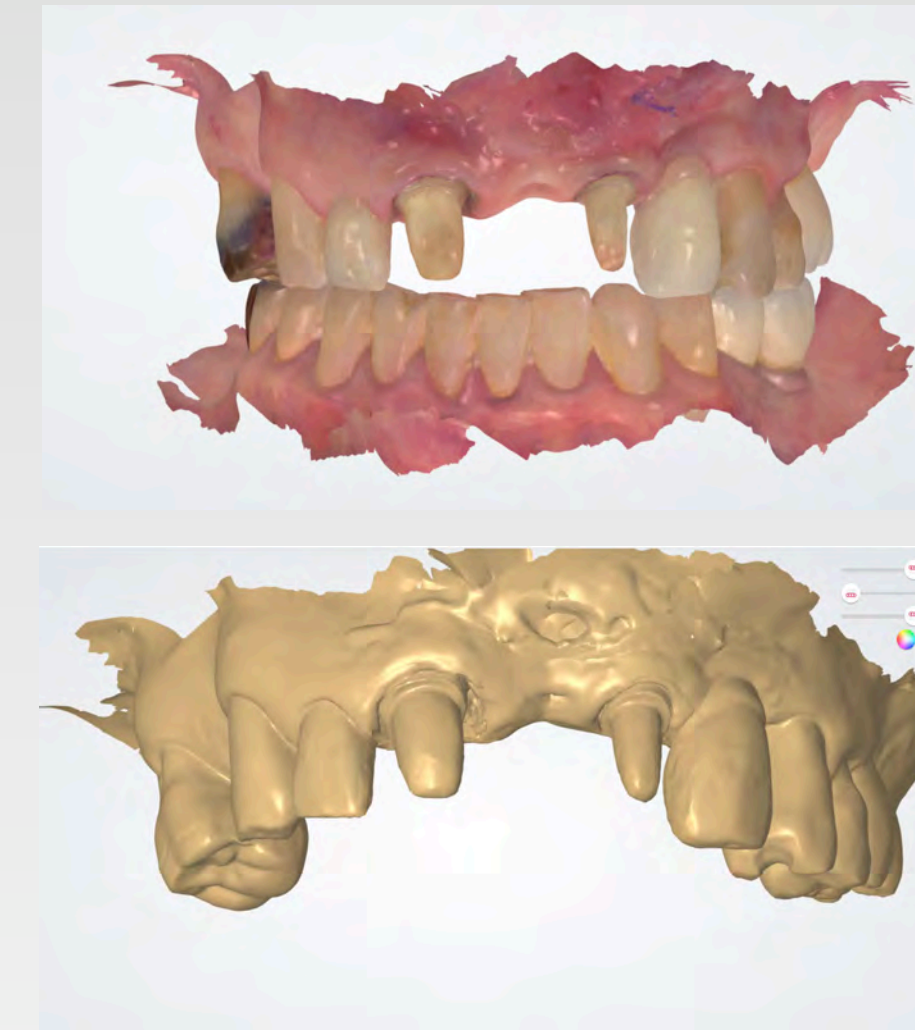
Image 10: Shows the full arch and occlusion of the patient. As shown, the patient has an edge-to-edge bite. Therefore, Monolithic Zirconia was determined to be the best material for this patient.

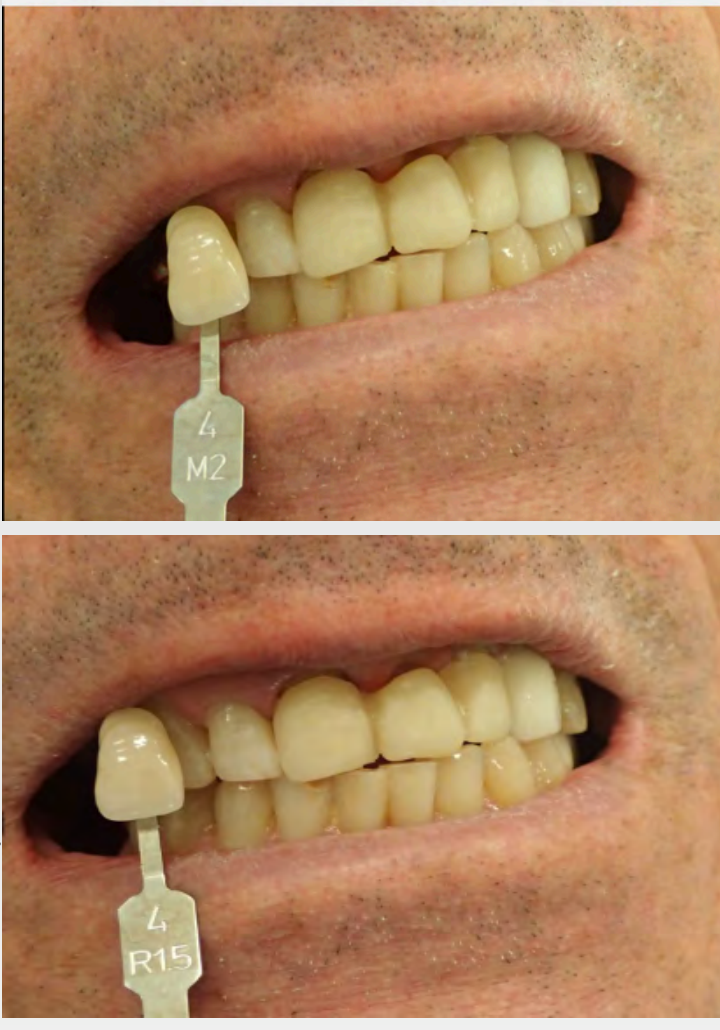
Image 11: Shows fabricated temporary. Due to Monolithic Zirconia being the material of choice, multiple shades were recorded to show characterization.

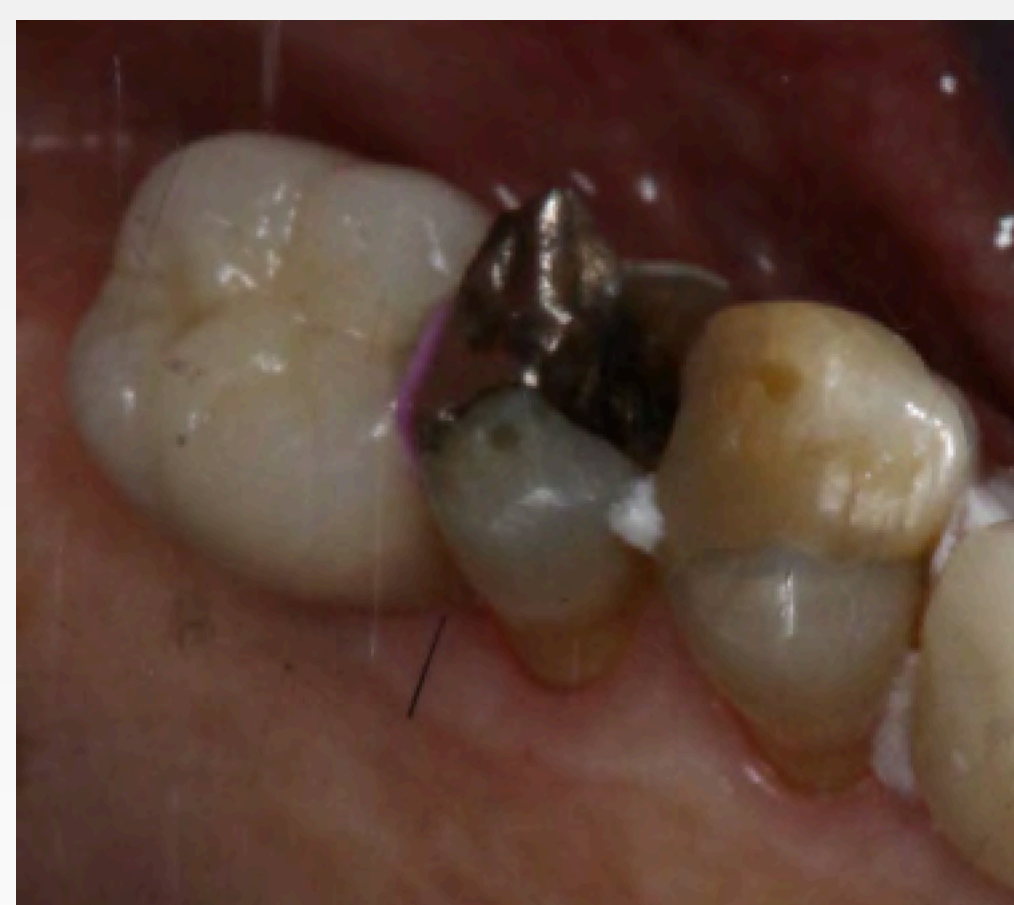
Image 13: Fractured #13 with existing gold onlay and pin

The patient presented with a recently extracted #5 and a fractured #13. #13 and #5 were addressed first to establish posterior occlusion. Site #5 was evaluated and required a 3 month re-assessment. #13 was addressed first. Due to the location of the fracture, the margin was able to be placed supra-gingivally and onto enamel. Therefore, #13 became a great candidate for CEREC Scanning, Milling, & Staining & Glazing. Due to the ability to bond to enamel, this increased the bonding strength for a Lithium Disilicate E. Max crown.³

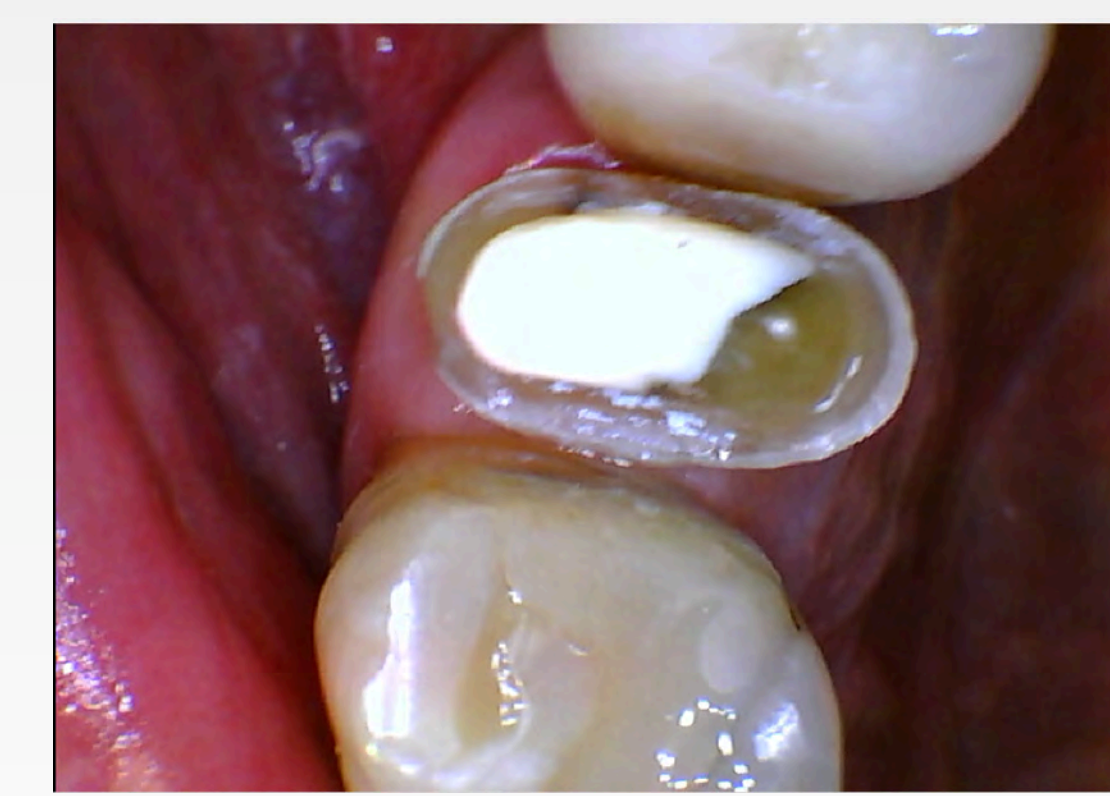
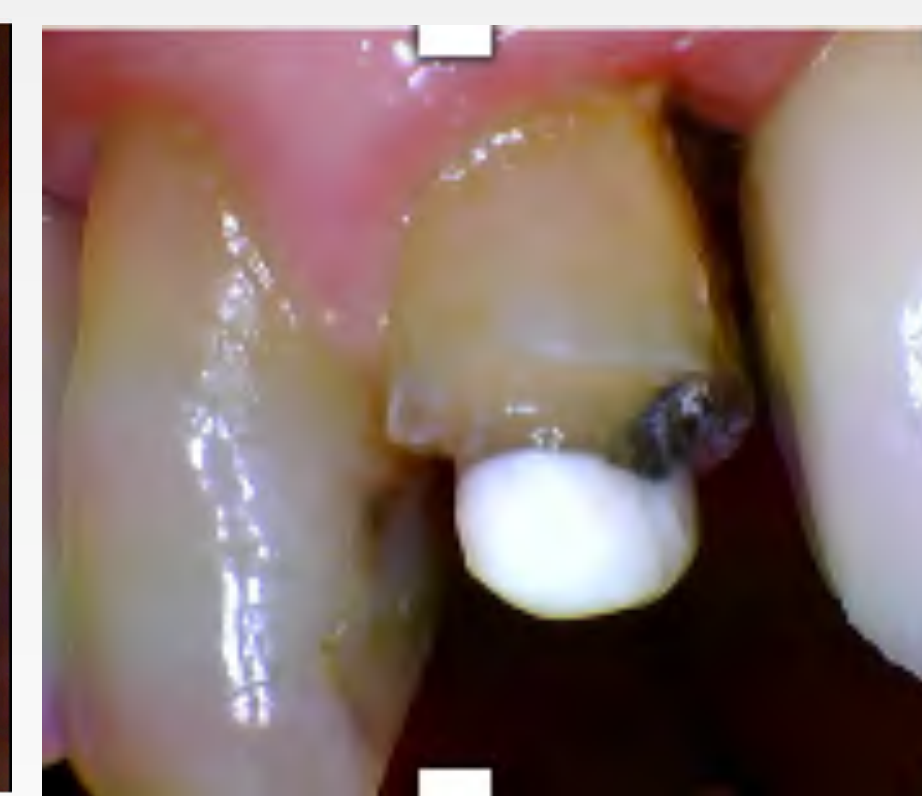
Image 14: The preparation was completed supra-gingivally so that tooth structure is conserved and to increase bonding on enamel.

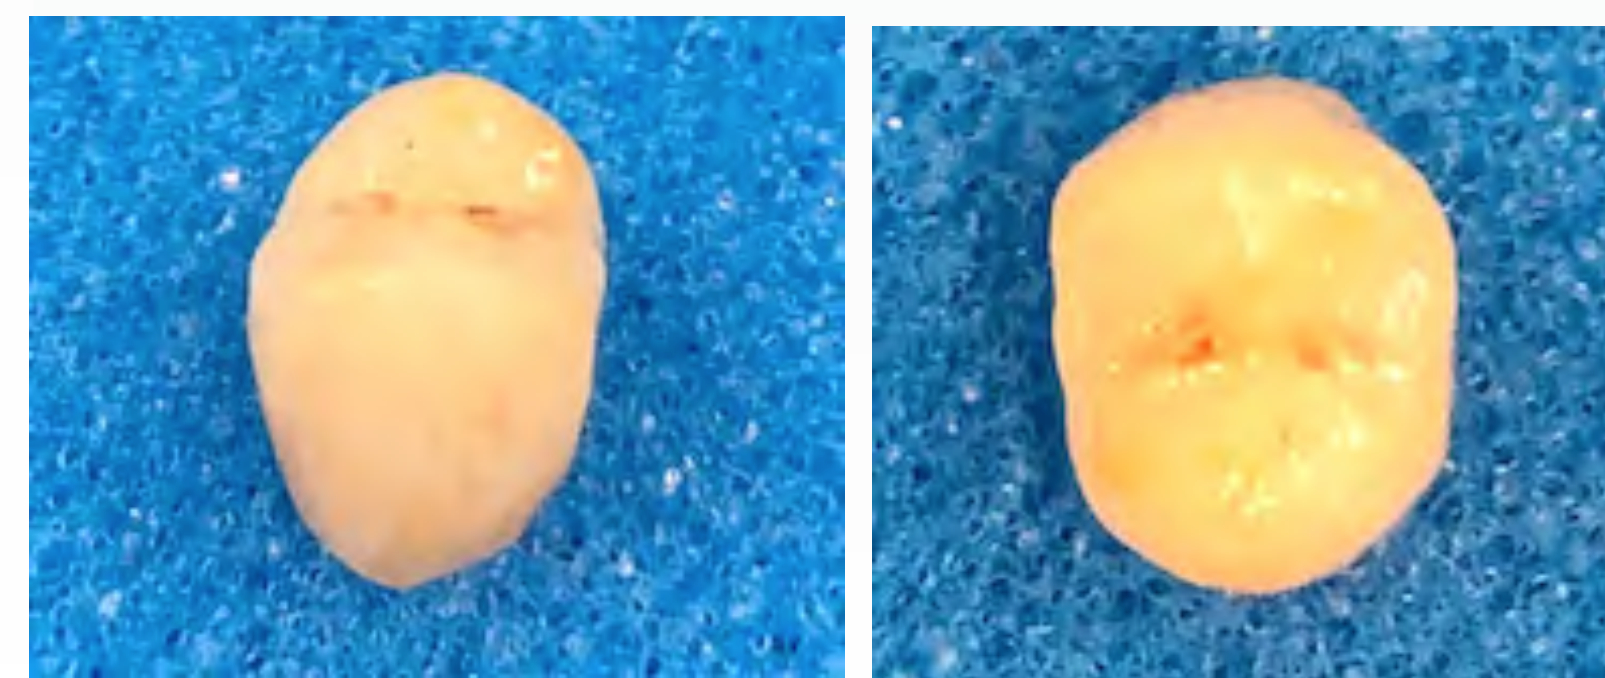
Image 15: #13 was designed and milled under the guidance of Dr. Tiller and stained and glazed under the guidance of Carlos Correa. All completed in house.

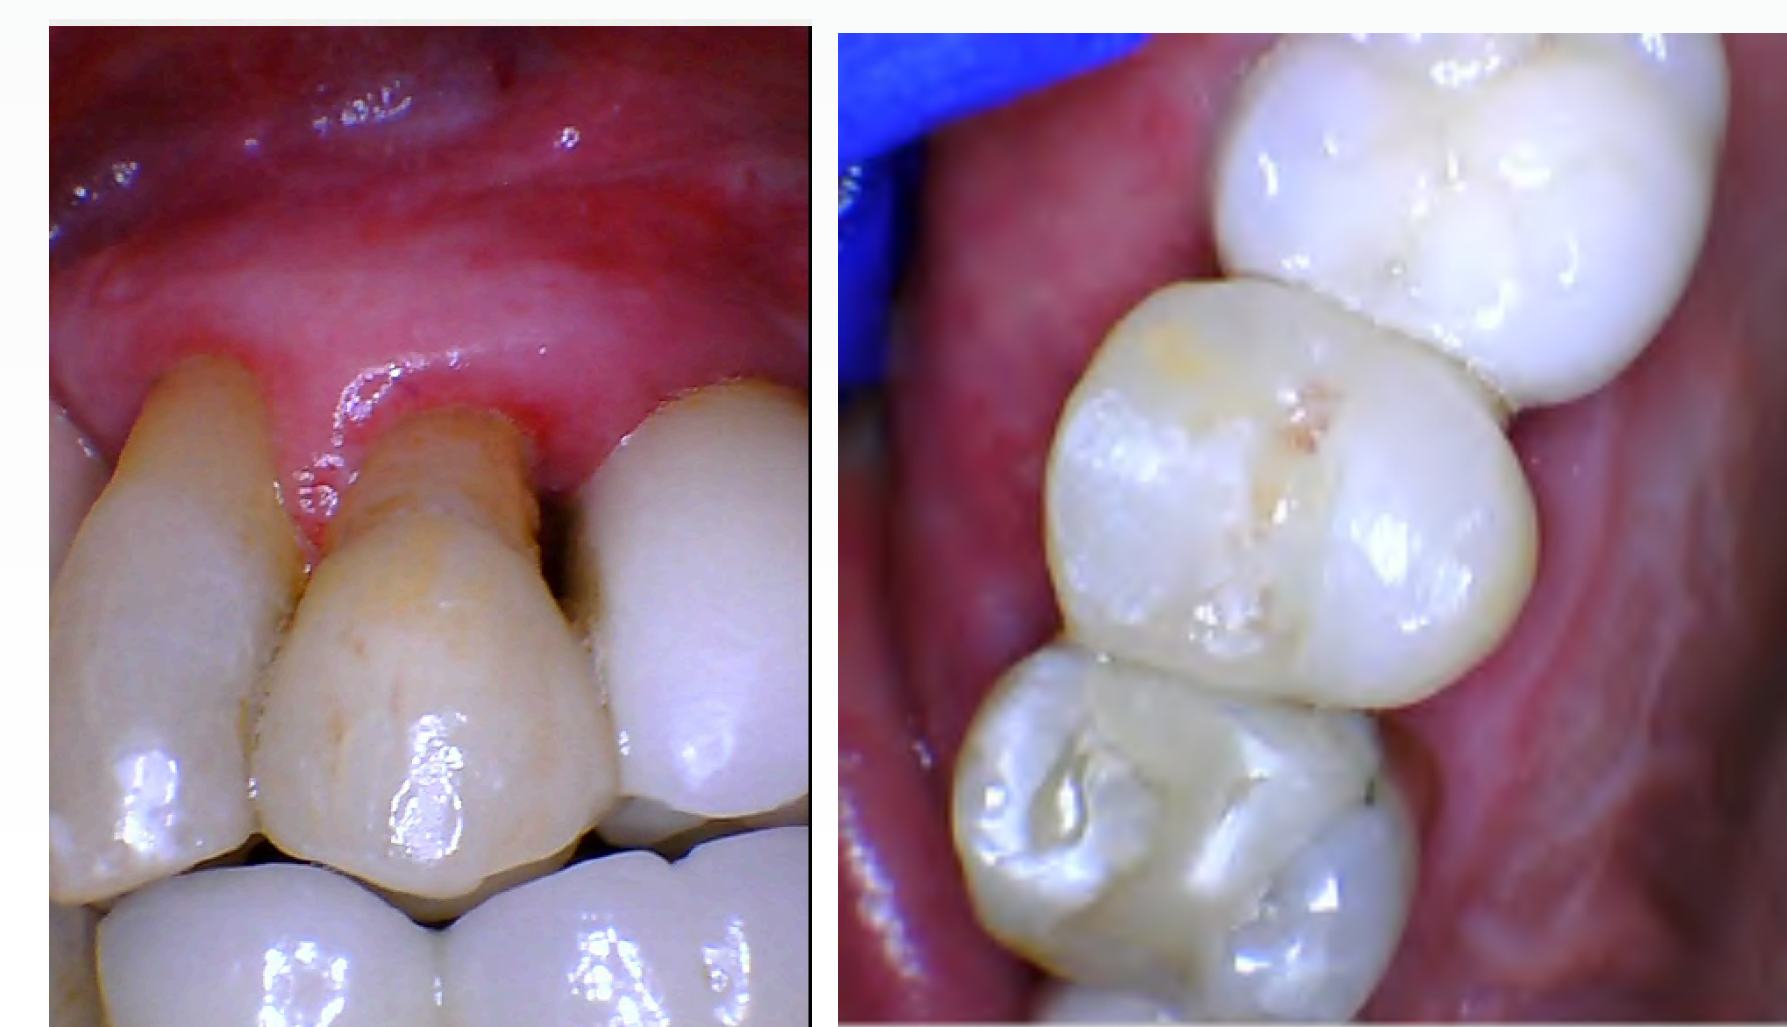
Image 16: Final Cementation of #13 crown. Detail given to capture natural esthetics.

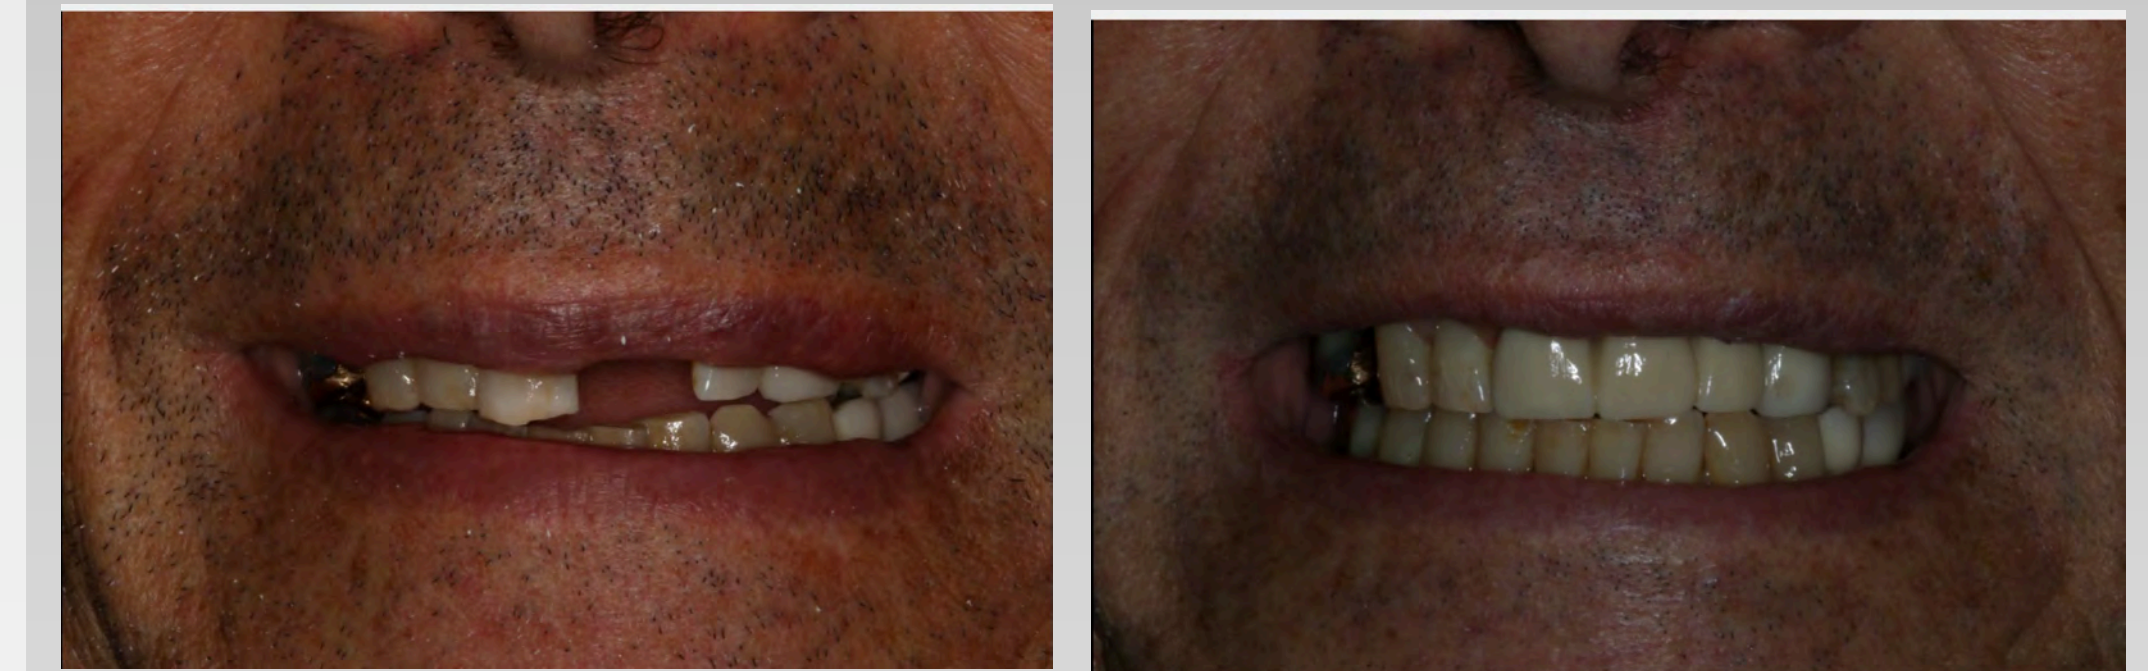
Image 15: Side by side before and after photographs of #8-#10
