Treatment of Loss of Vertical Dimension – A Case Presentation

Leah Life

D20268

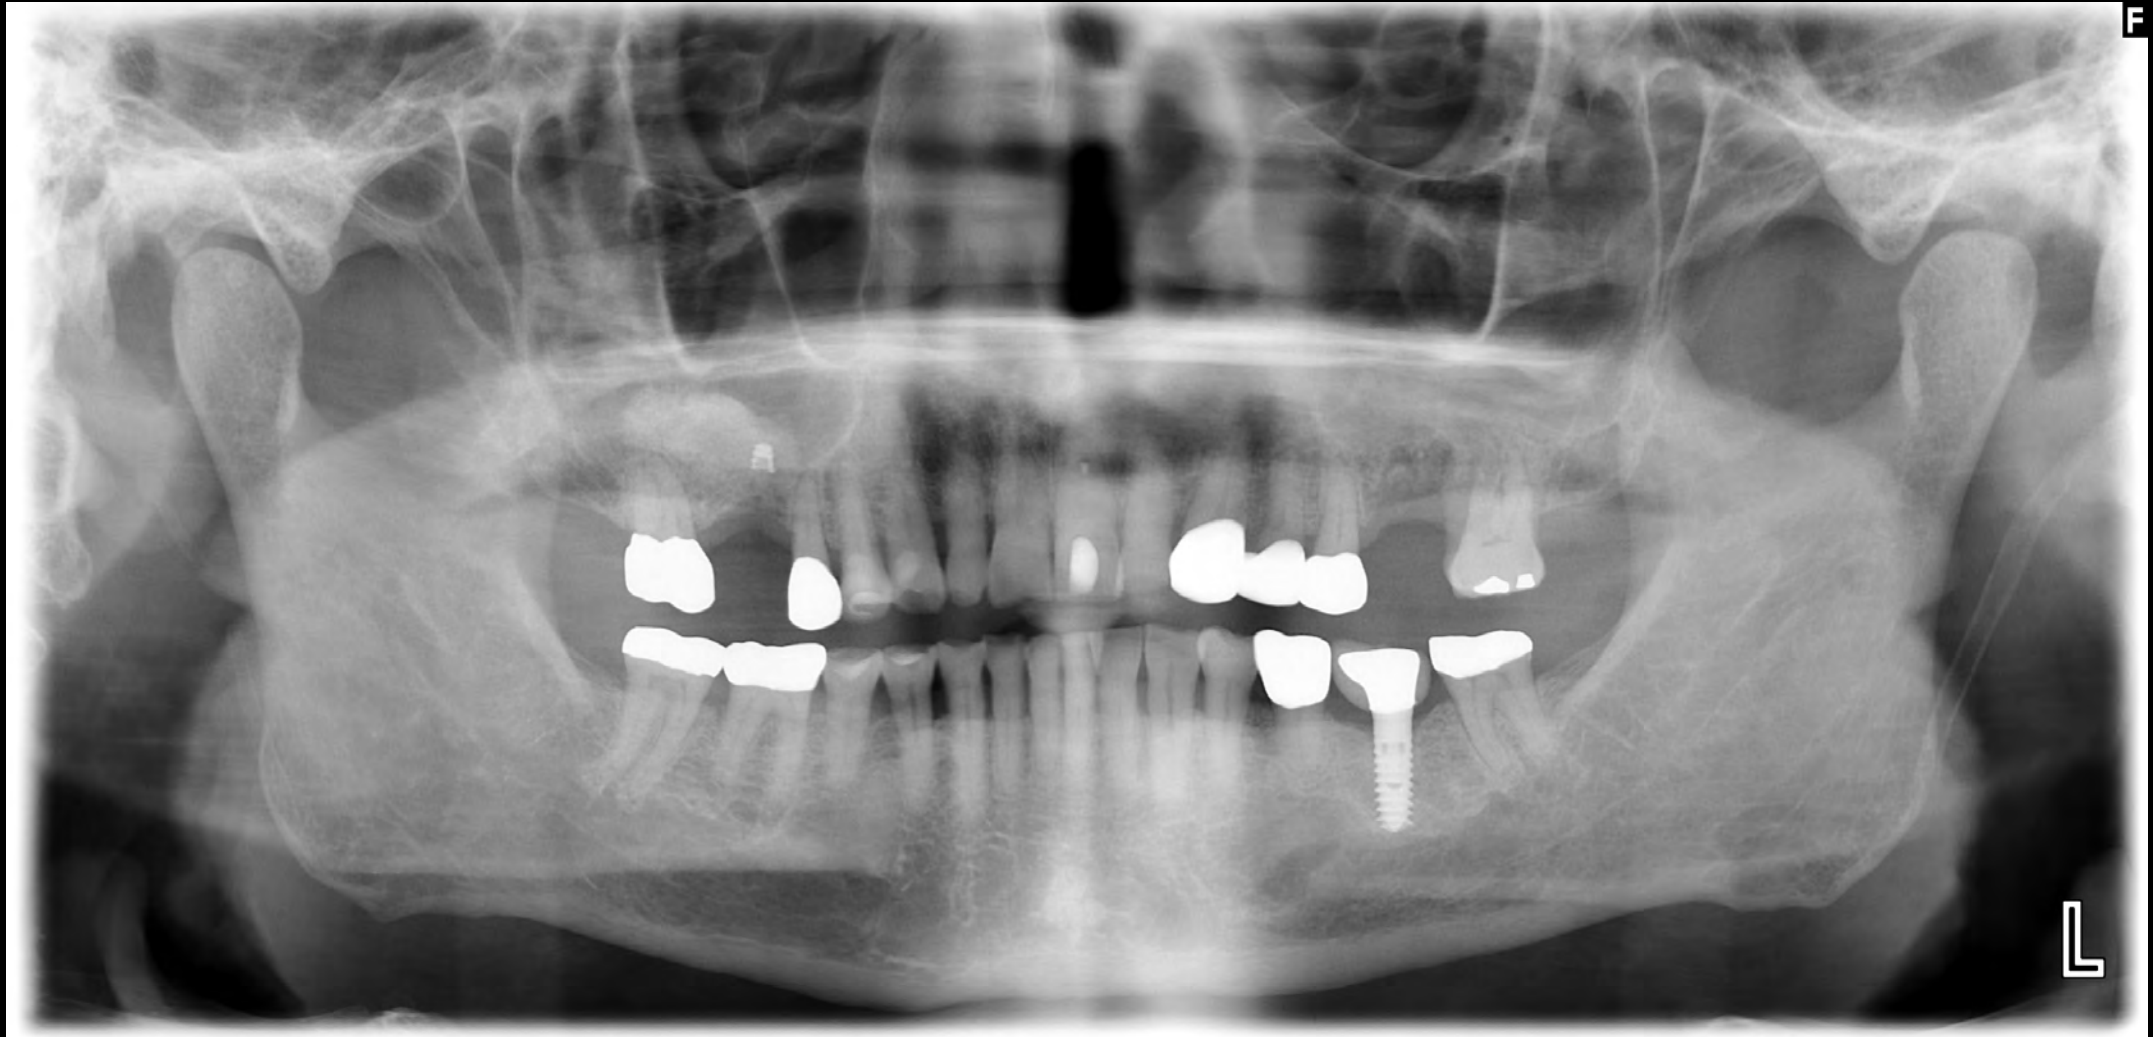
Pre-op Radiographs

- 67 yo M
- CC: "My implant broke and I want new implants"
- Med Hx: Type 2 Diabetes, Chronic Kidney Disease, Neuropathies, HTN
- Allergies: Pollen, cats, dogs, jellyfish
- Heavily restored, excessive wear and erosion, implants on #3 and #19, #14 recently extracted due to vertical root fracture
- Bruxism

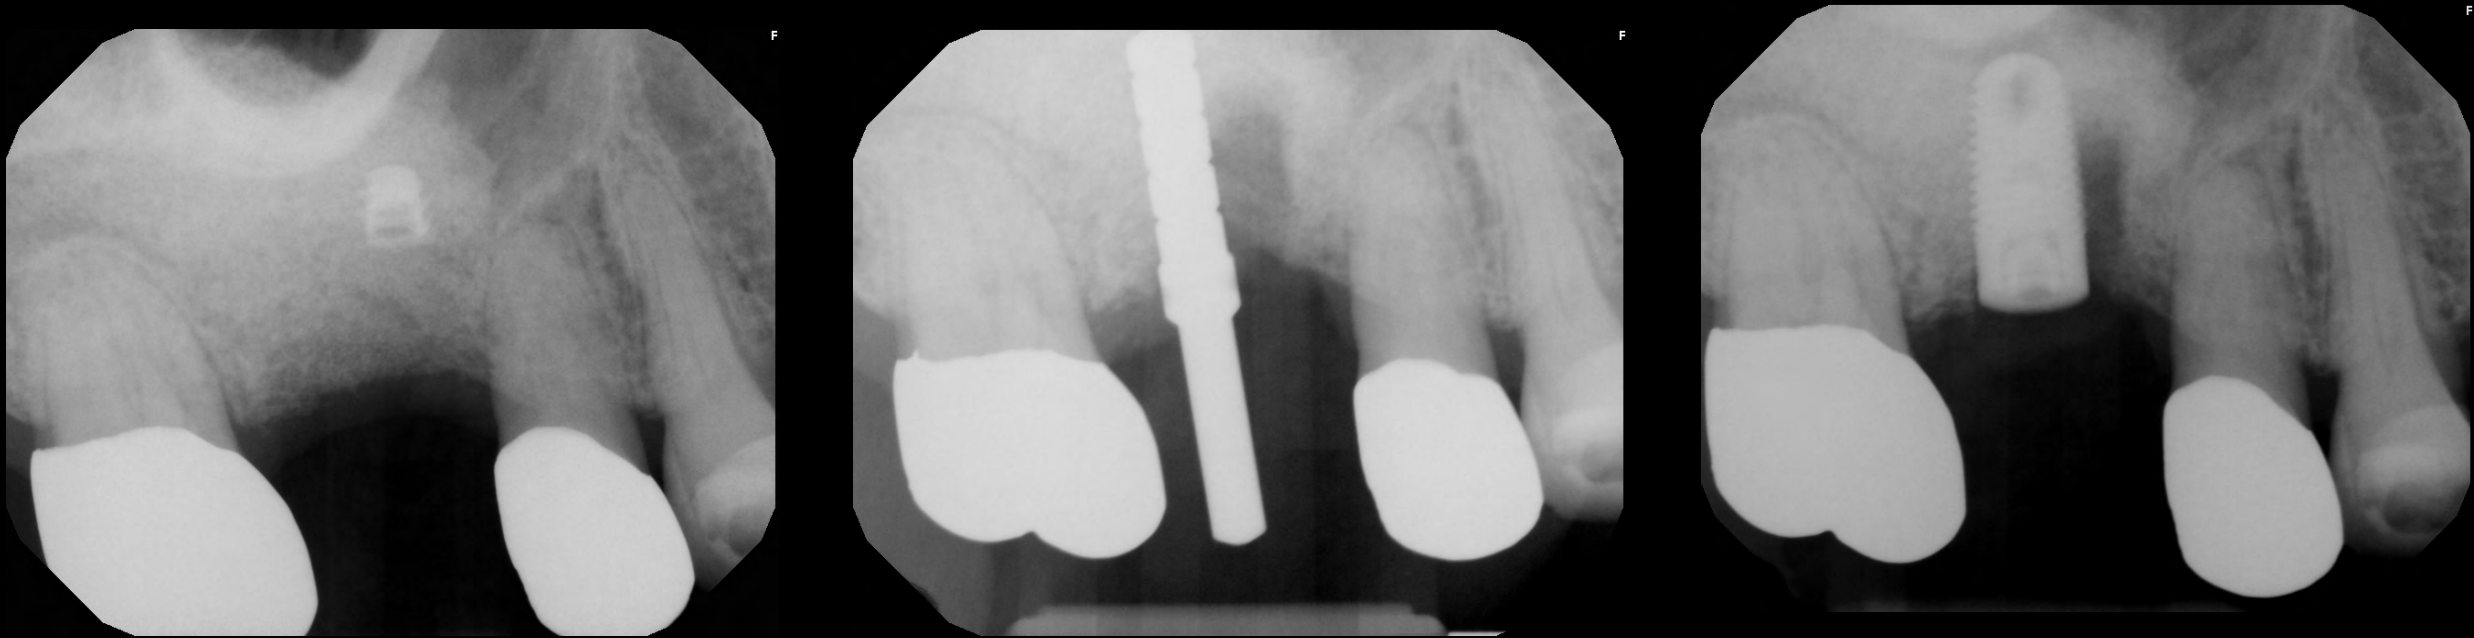
Implant Placement #3

Before our first exam – this patient was transferred to me from my big to proceed with implant removal at site #3, then subsequent placement at #3 and #14. We did a sinus lift on 14 and implant removal and placement at time of removal on #3 before I did my first recall exam with this patient.

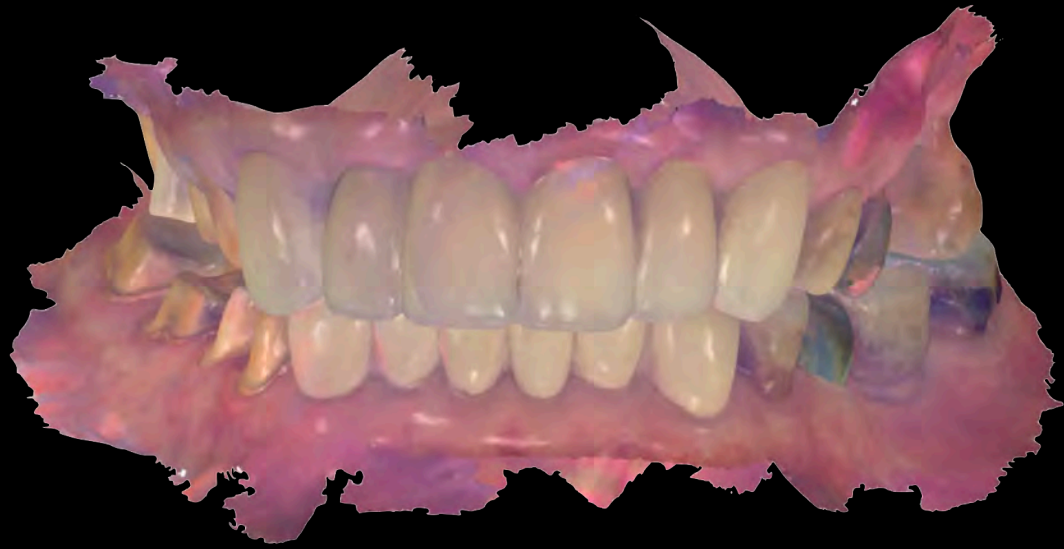
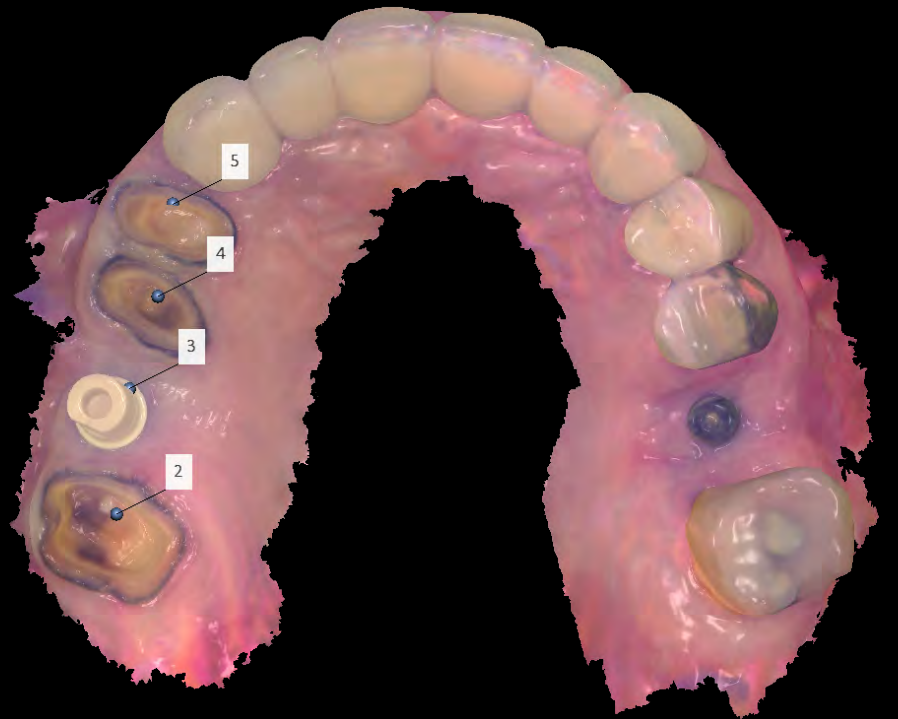
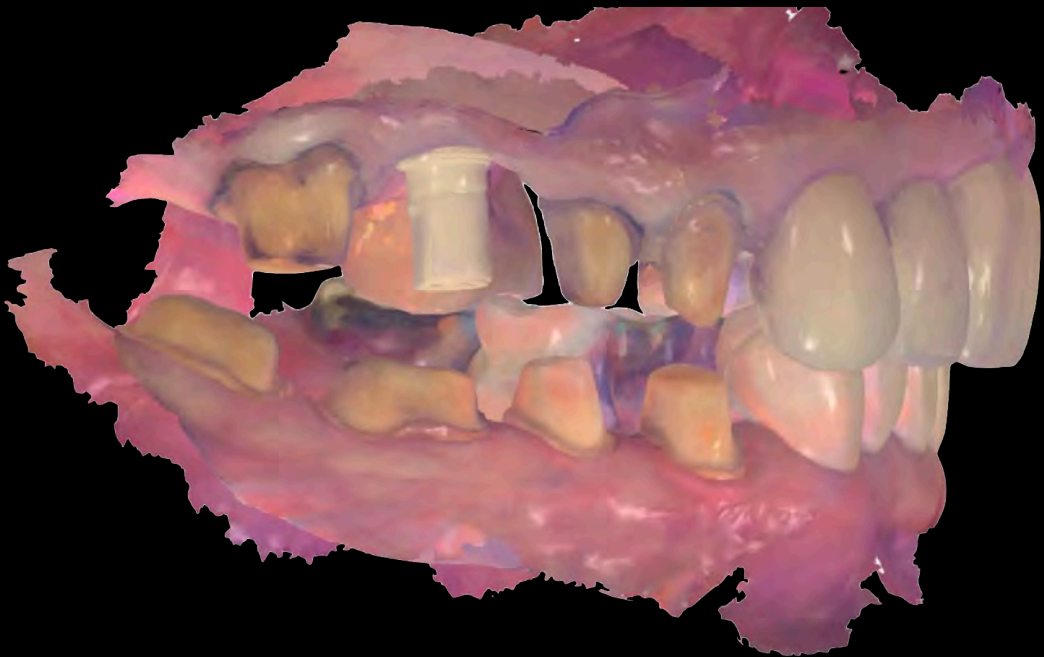
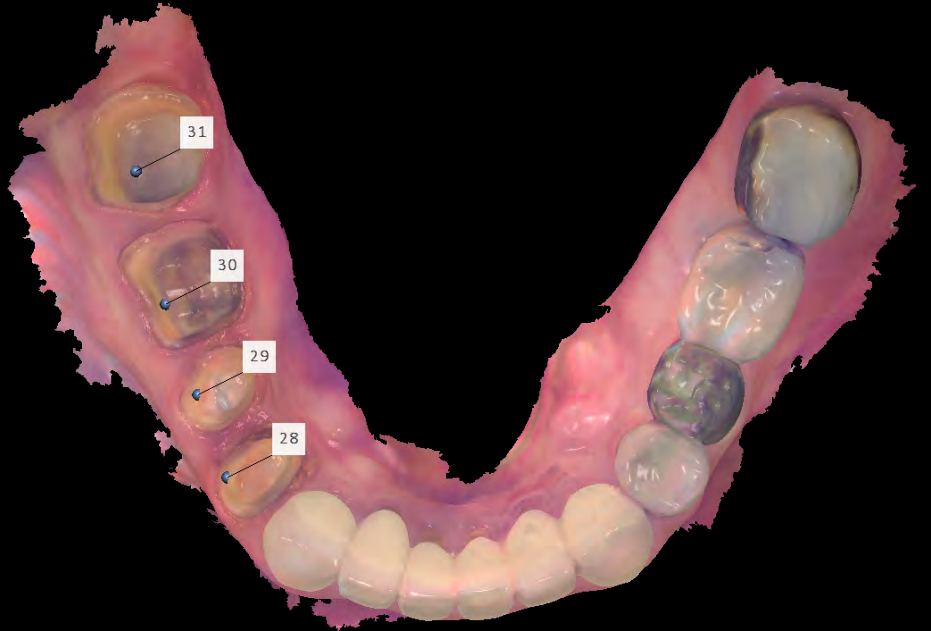
Split Mouth Study: UR/LR

- #3 implant restoration was sent back to the lab to recontour the restoration to help with possible food impaction, but the interproximal contours were all adequate

- Overall, the restorations in respect to adjacent hard tissue were excellent
 - However, there was a large palatal depression on the soft tissue lingual of #3 that was not picked up by the technician while fabricating the restoration, nor was it expressed by me to the lab to be aware of

- Prepared #2, 4, 5, 28, 29, 30 & 31 for full coverage crowns in one appointment (#3 is a screw-retained implant restoration)
- Next appointment: Scanned all eight units for their final restorations and took a prep index to send to the lab for help mounting the case

- Worked with Carlos in the lab to deliver these units fully digital - we scanned them and the lab took it from there to mount the models and fabricate the units

- Tried to eliminate as much human error as possible by having a professional lab tech perform these steps
- Delivery day
 - All four lowers units were delivered without any interproximal reduction needed

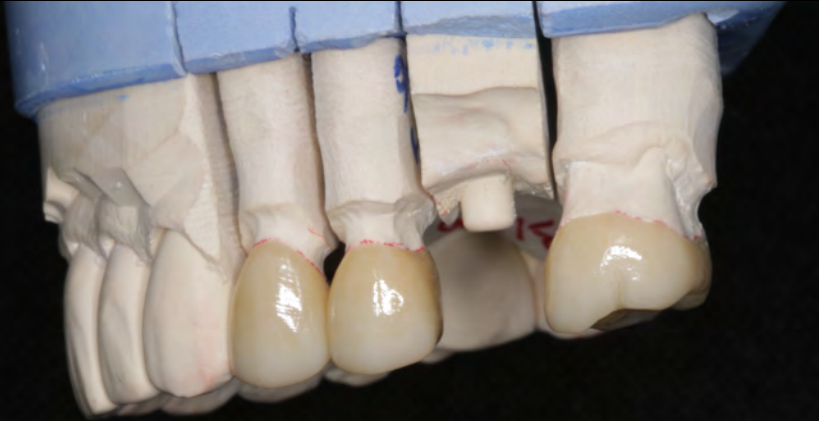
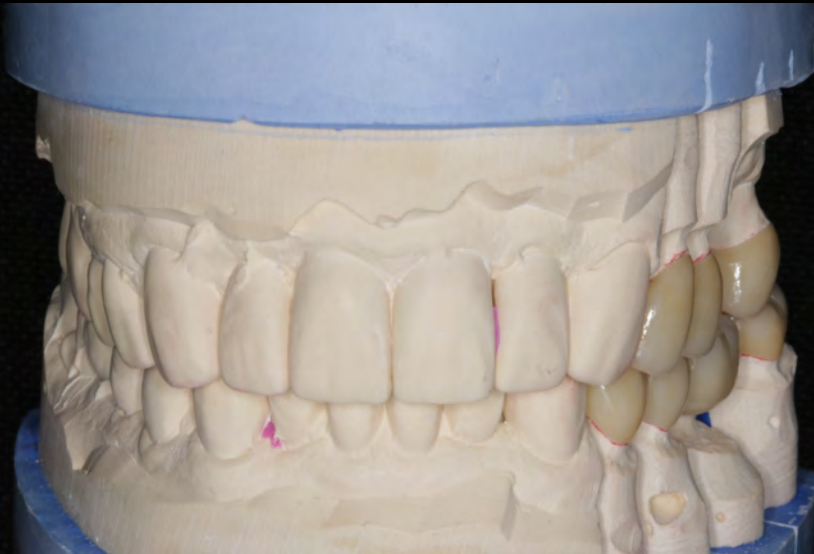
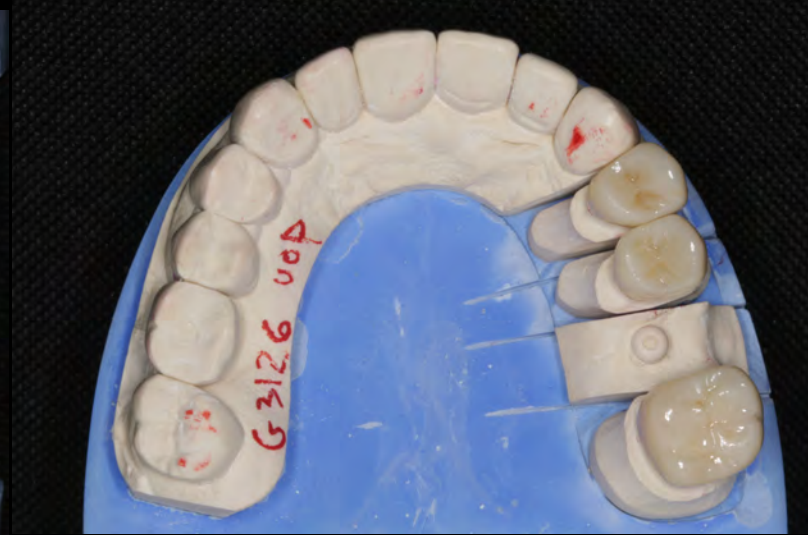
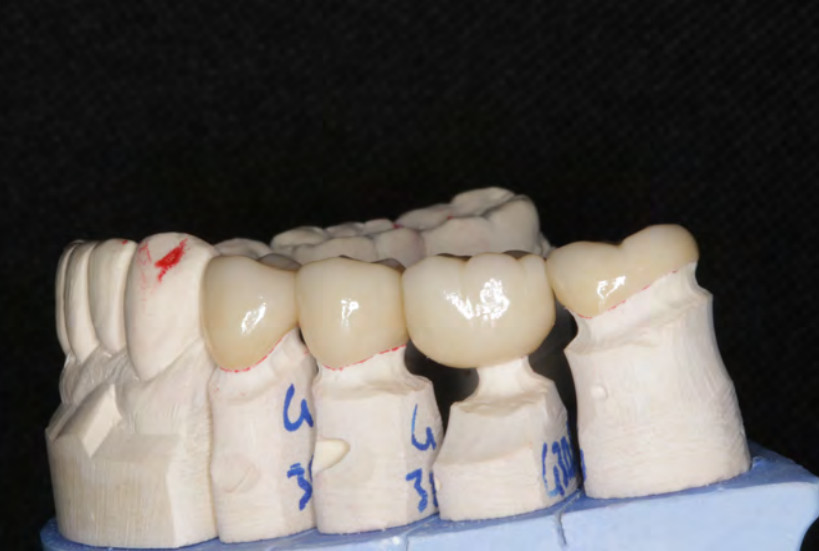
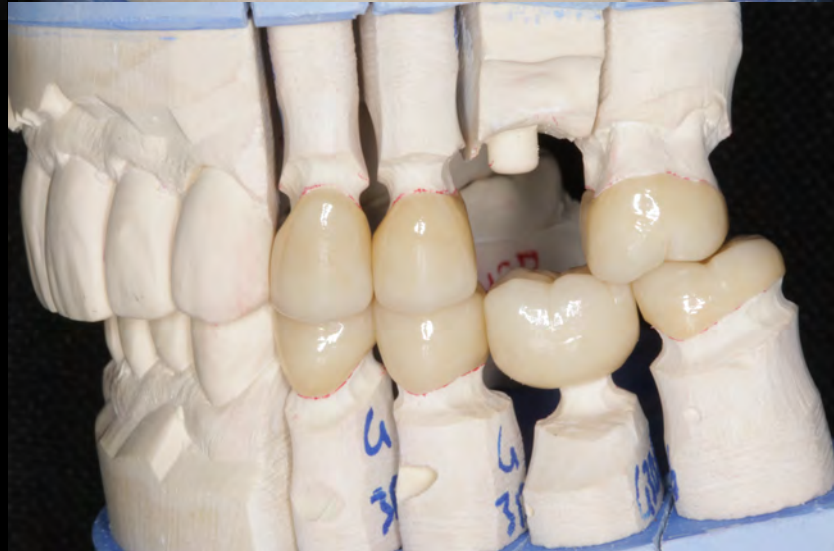
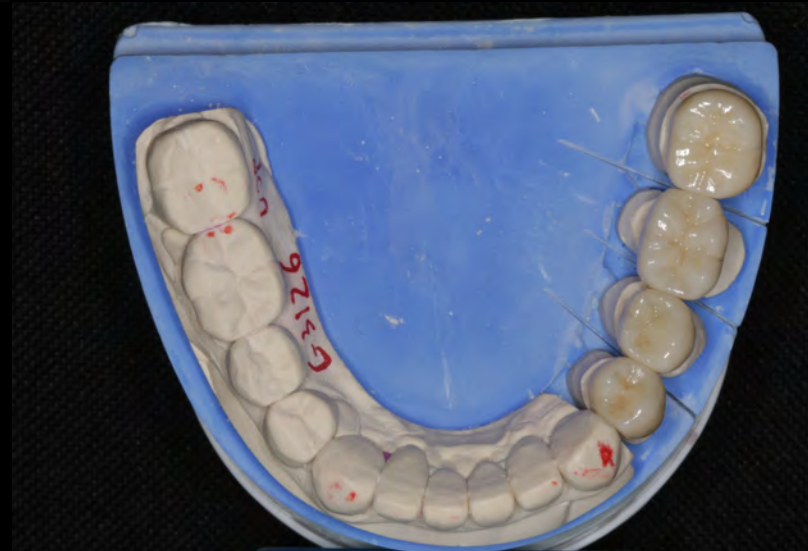
Posterior UL/LL Final Restorations

- CIMOE 12, 13 and 15 with no adjustments, but the LL required a lot between 18, 19 and 20.
- Based on this split mouth study, there seems to be more accuracy with the completely digital fabrication method. This could be due to the human error I induced during impression or mounting. It seems in my hands that digital may be a better route.

- Prepared 12, 13, 15, 18, 20 and 21 for full coverage crowns (#14 was an implant that needed another month until our osseointegration check and #19 was a previous implant placed at another dental office with a system we do not use)

- I reached out to the company and they do not even fabricate implant parts for that system anymore. I then removed the old, fractured crown on #19 and lightly prepped the prefabricated abutment to define a margin line for the new cement-retained crown.

- Putty and light body technique to capture the impression for three teeth in the UL and all four units on the LL
 - Prep index with vanilla bite to help mount the models when I received them back from the lab.

- Received the master casts back from the lab and mounted them and sent them back for final restorations
- Delivery day
 - Needed to make more adjustments to the LL quadrant than I did any other quadrant

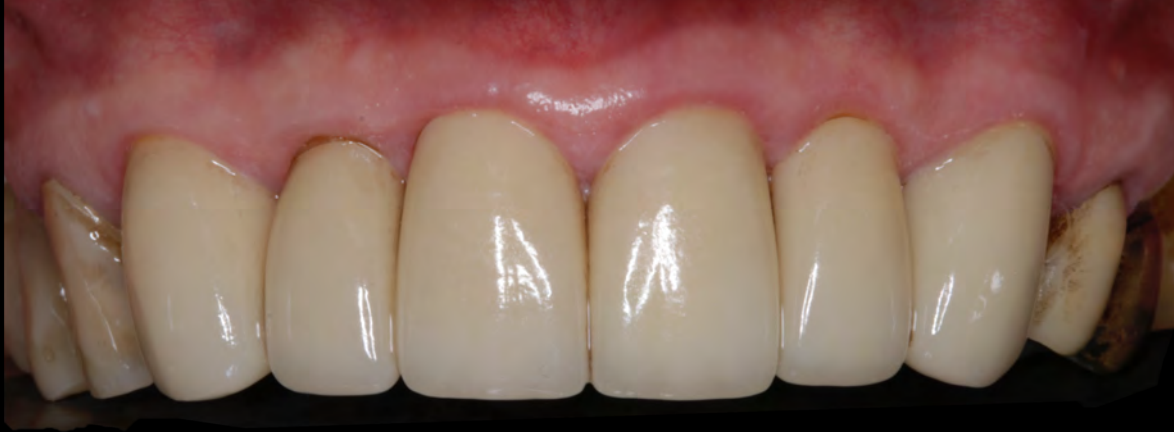
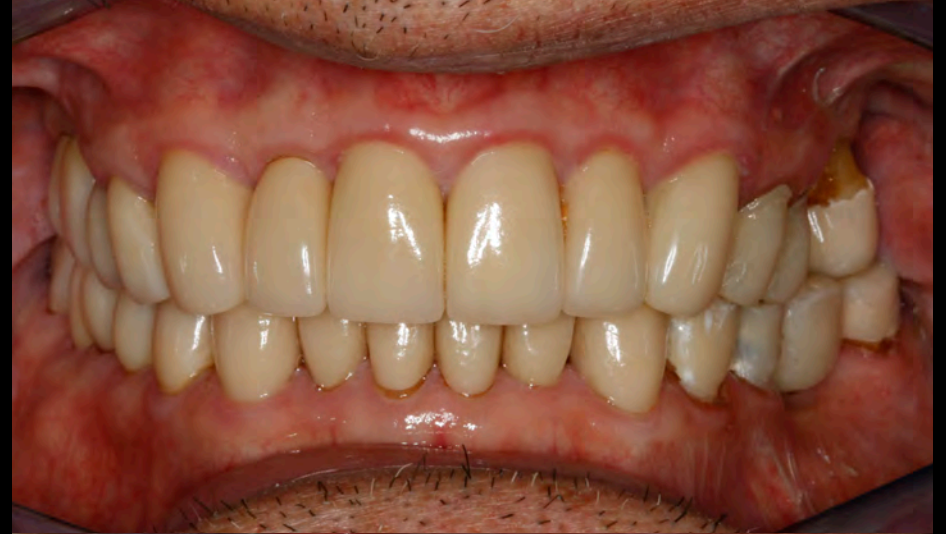
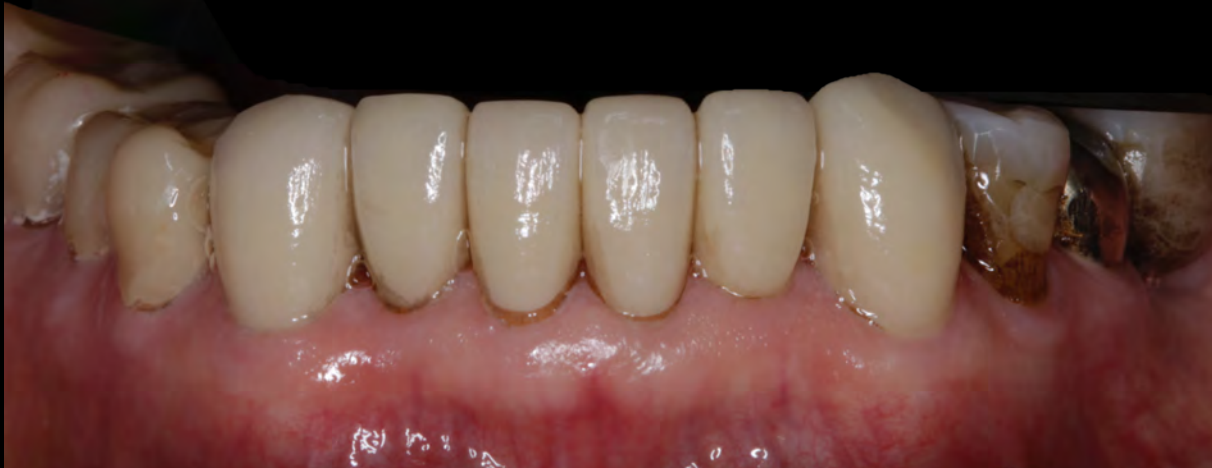
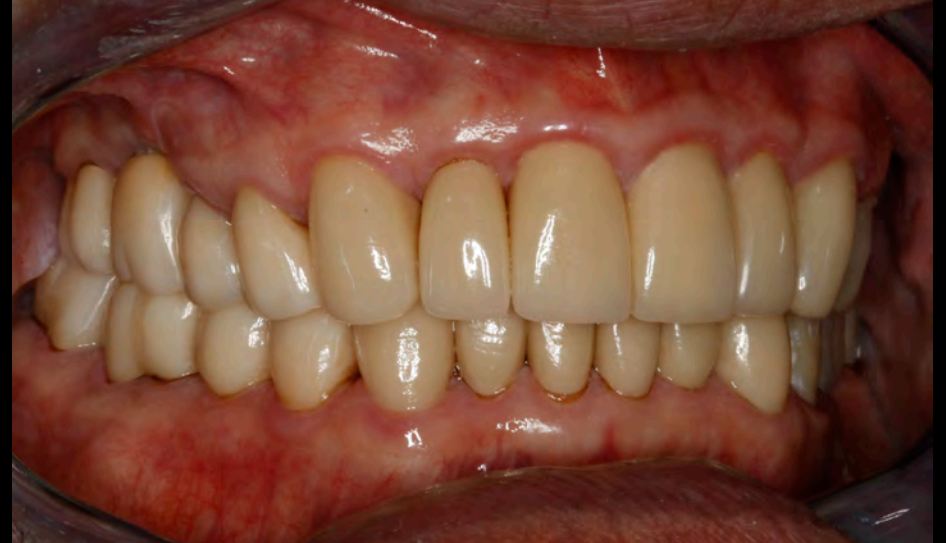
Final Restorations

NOTE: I have delivered every crown but #14 at this point. Was waiting to take final photos, but have not been able to under the current circumstances. The photos on the right are with the temporaries on the left side

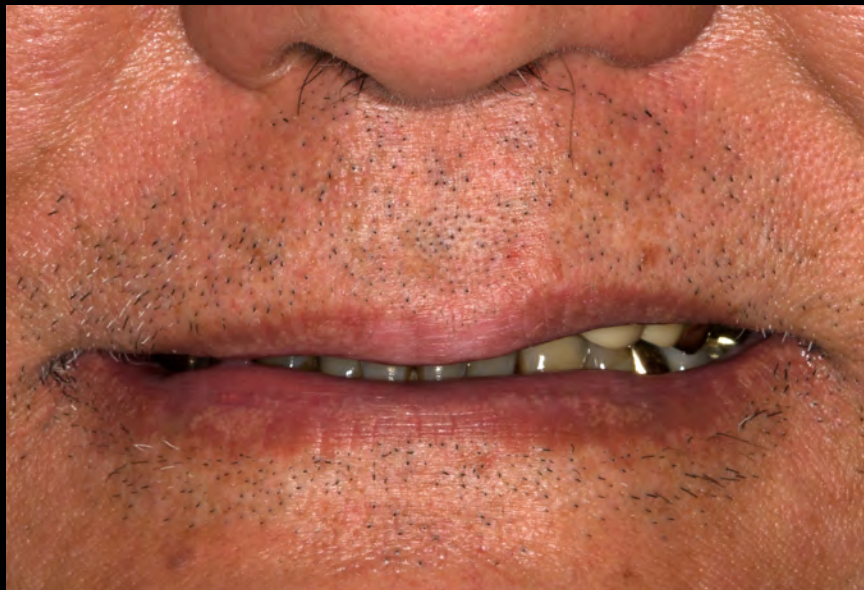
Incisal Display

- Spear et al. 2006: Incisal display at 60 yo, on avg. 1 mm
