A Multidisciplinary Oral Rehabilitation

— Ramteen Rafii - DDS 2021 —

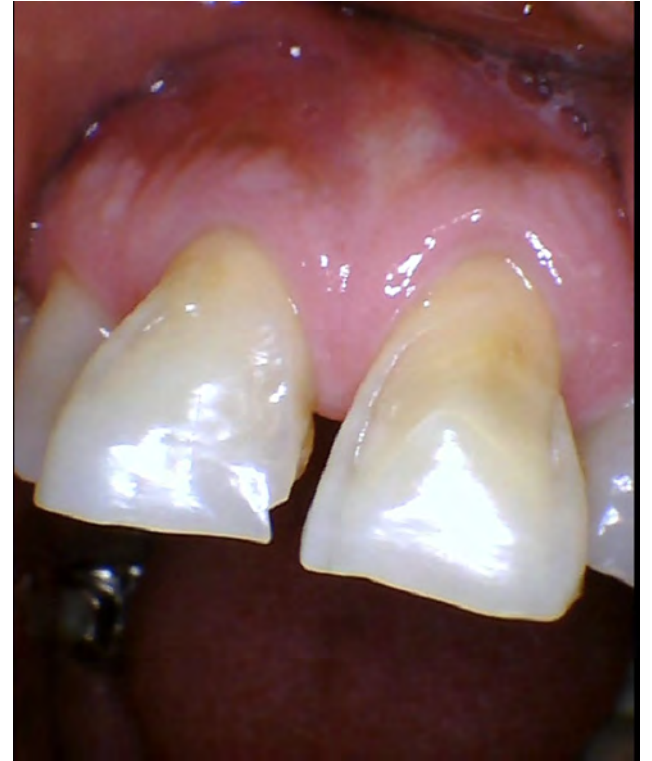
- Erosion Visualized on both F and L surfaces of #8 & #9
- Missing ML restoration on #8

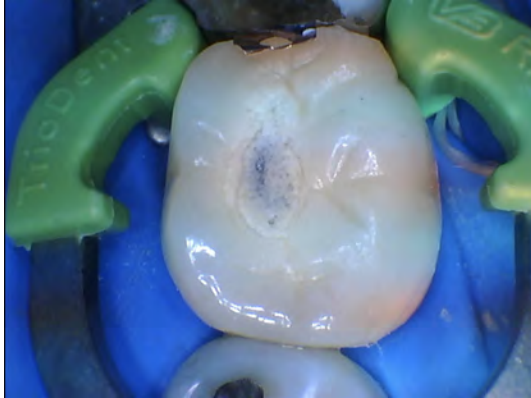
- Large MO amalgam and fractured ML cusp on #18
- PFM crown on #19. Recurrent Decay was seen clinically

Radiolucency from Fractured Cusp

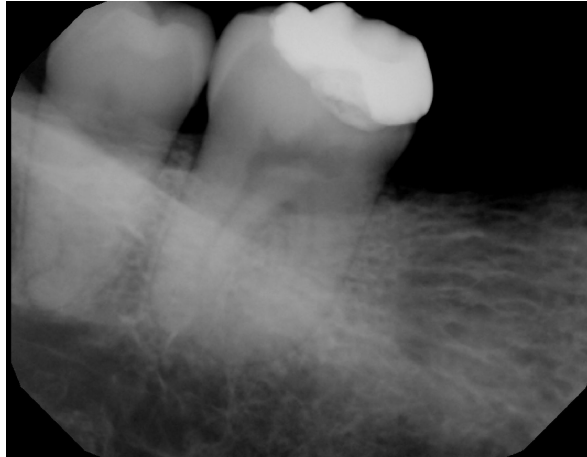
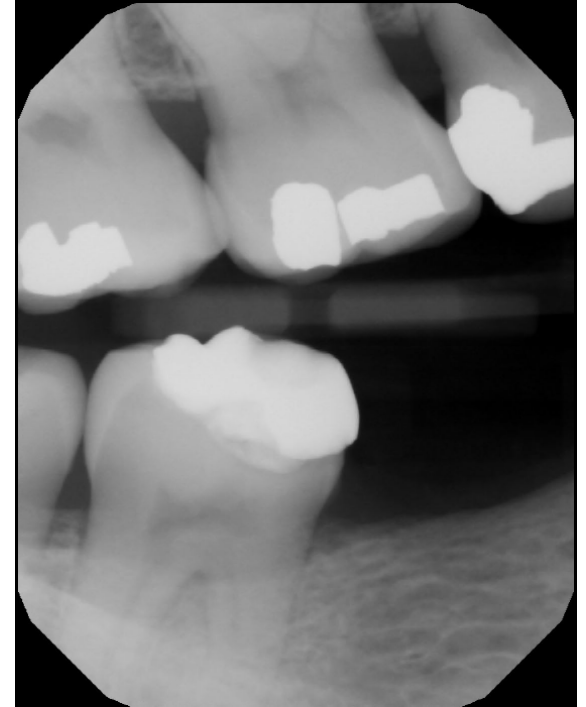
- #31 is tipped mesially due to loss of #29 and #30
- Onlay of #31 has an open margin and recurrent decay

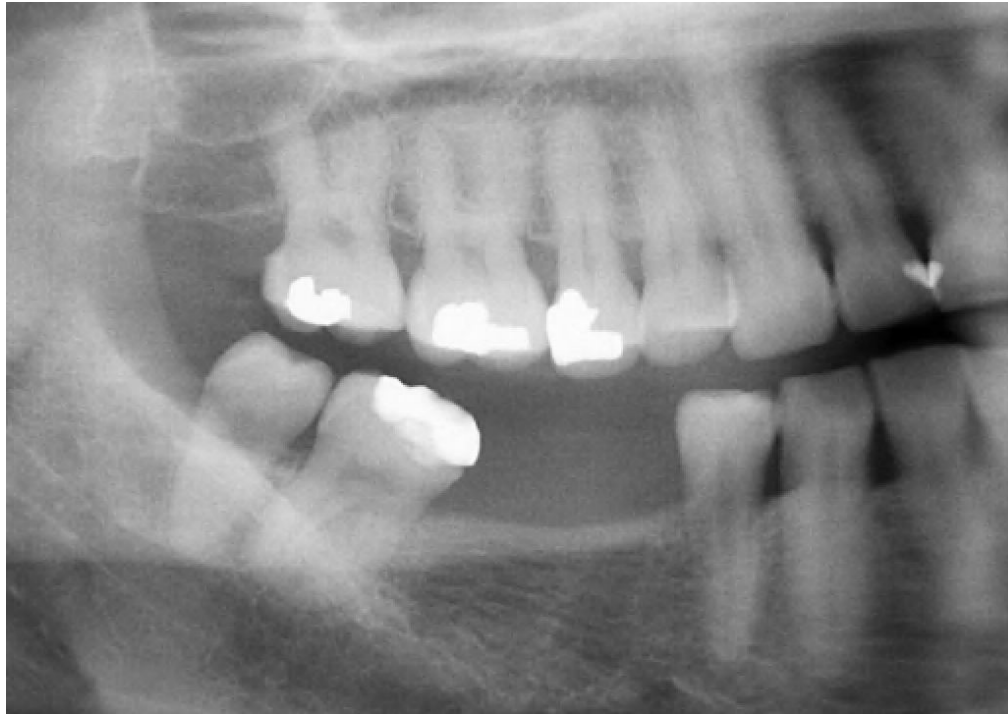
Problem: Insufficient space for 2 implant crowns

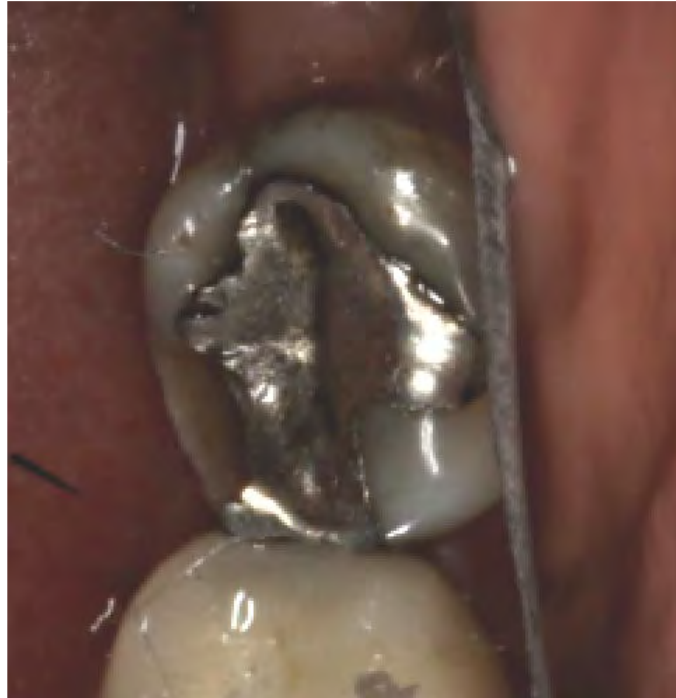
#18 Presented with Large MO amalgam and ML cusp Fracture

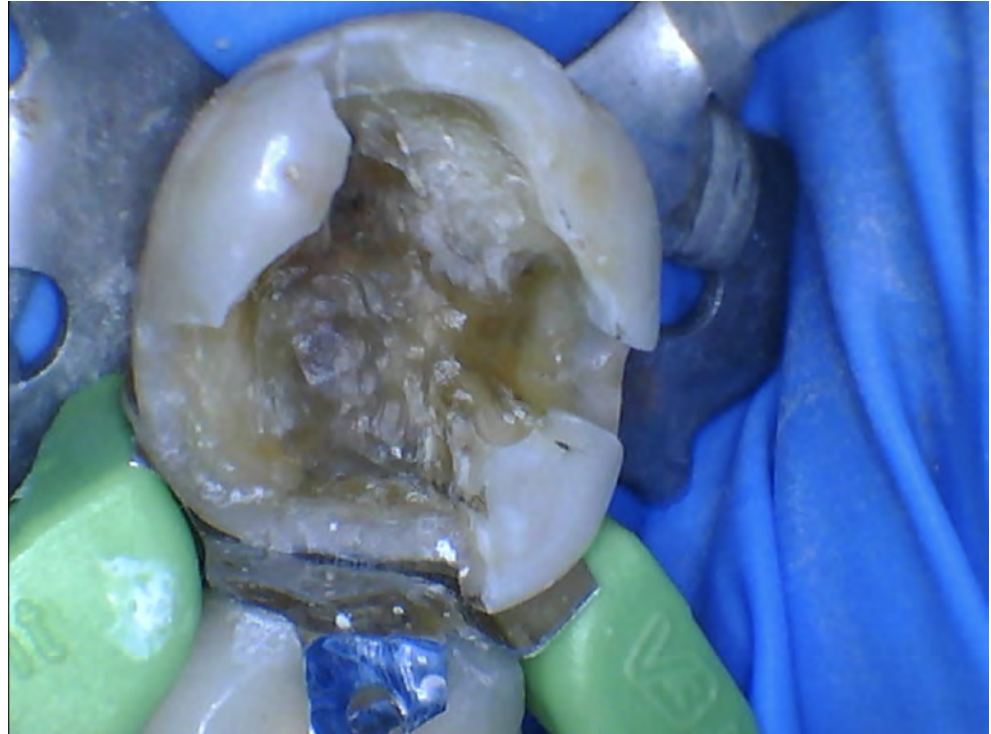
- Rubber dam isolation used for amalgam/caries removal and isolation for buildup
- All remaining tooth structure is hard and non carious
- Staining observed from amalgam restoration

Old restoration and caries removed

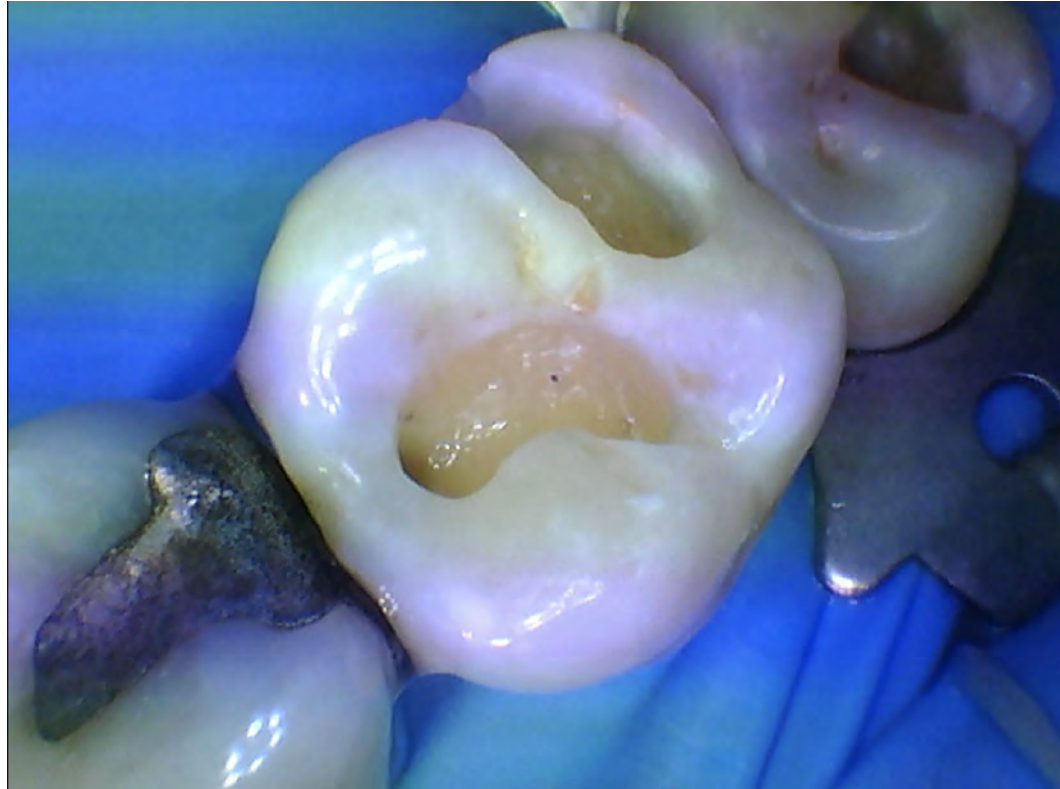
No Recurrent Decay found

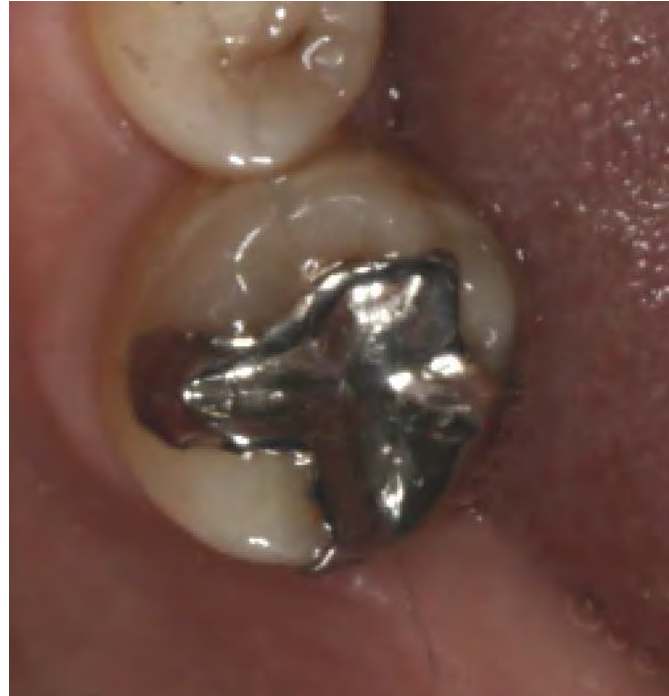
#31 Onlay with open margin and recurrent decay

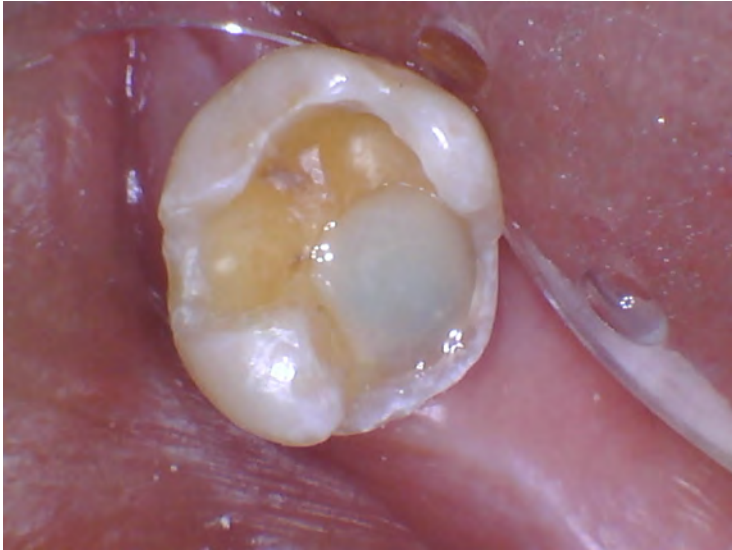
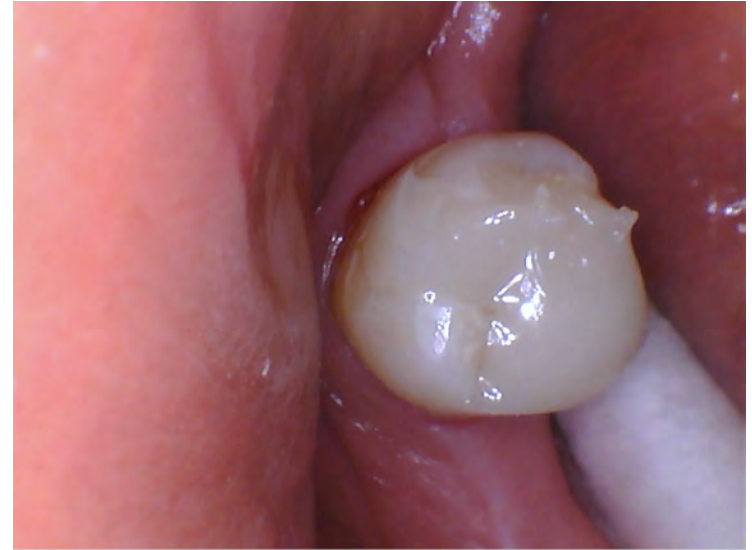
Notes: A little less activa could have been used

Buildup has not yet been finished/polished

Activa and Buildup Placed
